2023 Polling Site Accessibility Report: Marion County, WV

On August 1 and 2, 2023, a DRWV Advocate completed exterior accessibility monitoring of all precincts in Marion County and this report contains our findings. The following ADA codes referenced below are the most common issues noted in this county.

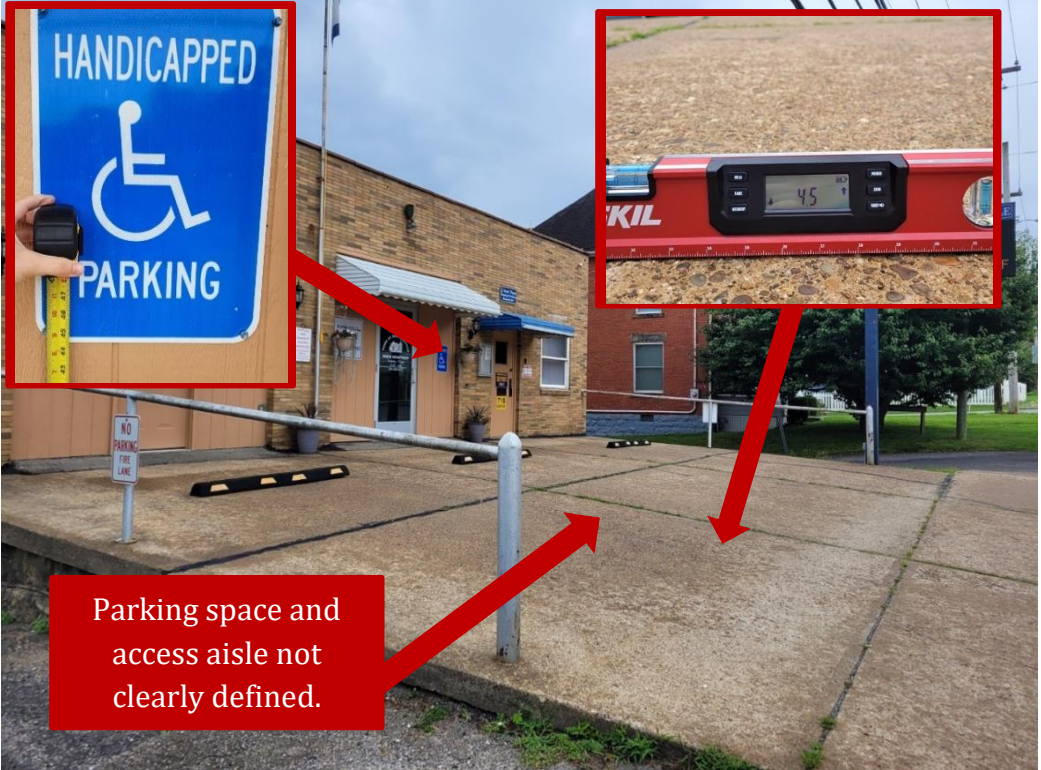
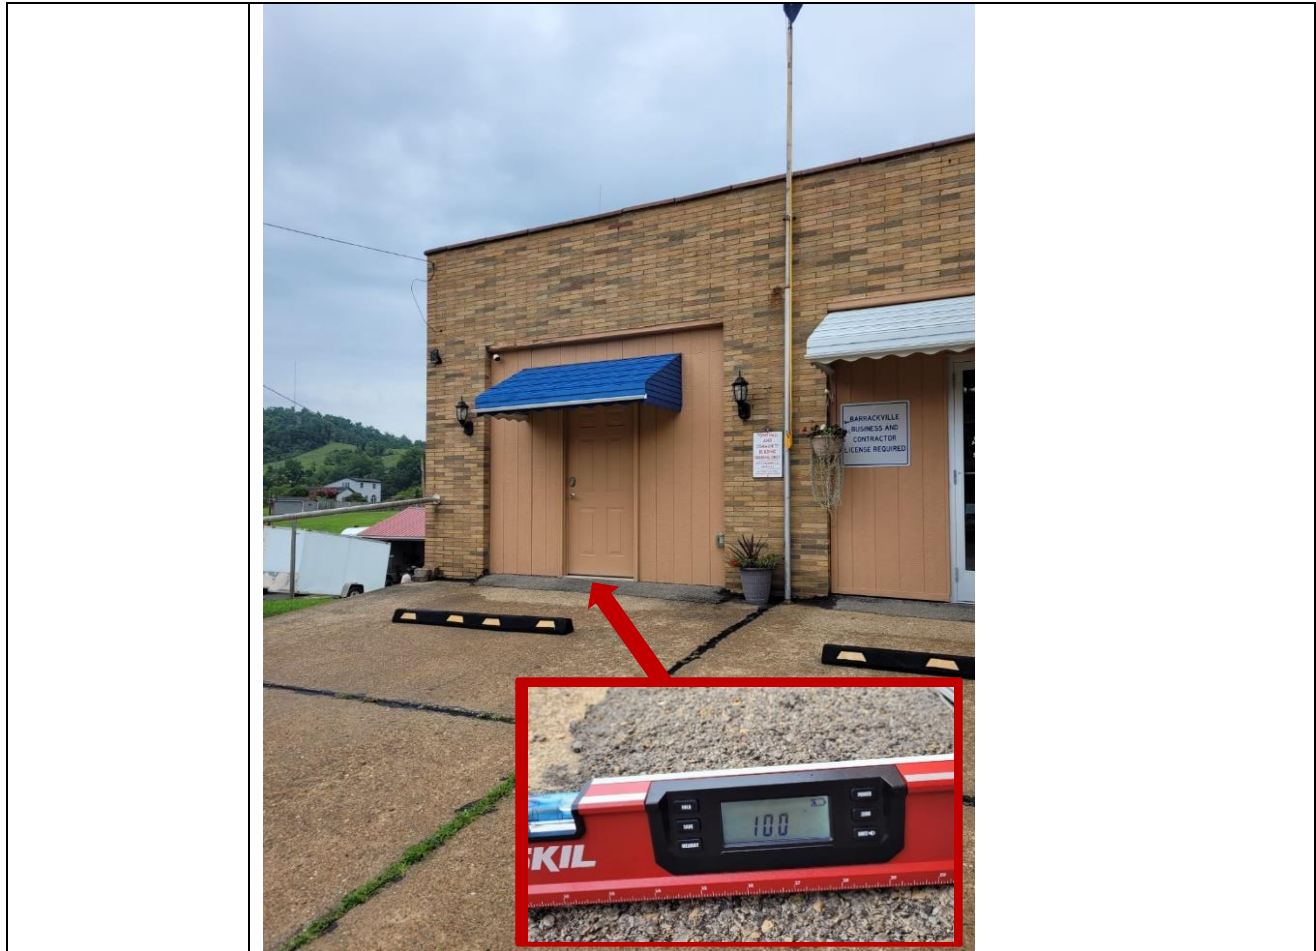
Barrackville Community Building	
Issue(s)	The existing parking signage is not displayed at the proper height (502.6). The accessible parking space and access aisle are not clearly defined (502.2). The slope of the parking facility exceeds ADA Standards (502.2, 502.4). The slope of the access route (ramp up to entrance door) exceeds ADA Standards (302.1).
Exhibit

<p>The photograph shows the exterior of the Barrackville Community Building with a designated accessible parking space. A blue sign with a wheelchair icon and the words "HANDICAPPED PARKING" is mounted on a post. A hand is holding a yellow measuring tape against the sign. A red level is placed on the ground surface, showing a reading of 4.5. A red text box at the bottom of the image states "Parking space and access aisle not clearly defined." with red arrows pointing to the parking area and the level.</p>

Suggestions for ADA Compliance	The front entrance is not accessible due to the excessive slope of the parking facility and door threshold. Utilize another entrance that may better comply with ADA Standards; There is a side entrance in compliance with ADA Standards with a paved area in the rear of the building that could be used for accessible parking spaces if marked appropriately.
---------------------------------------	---

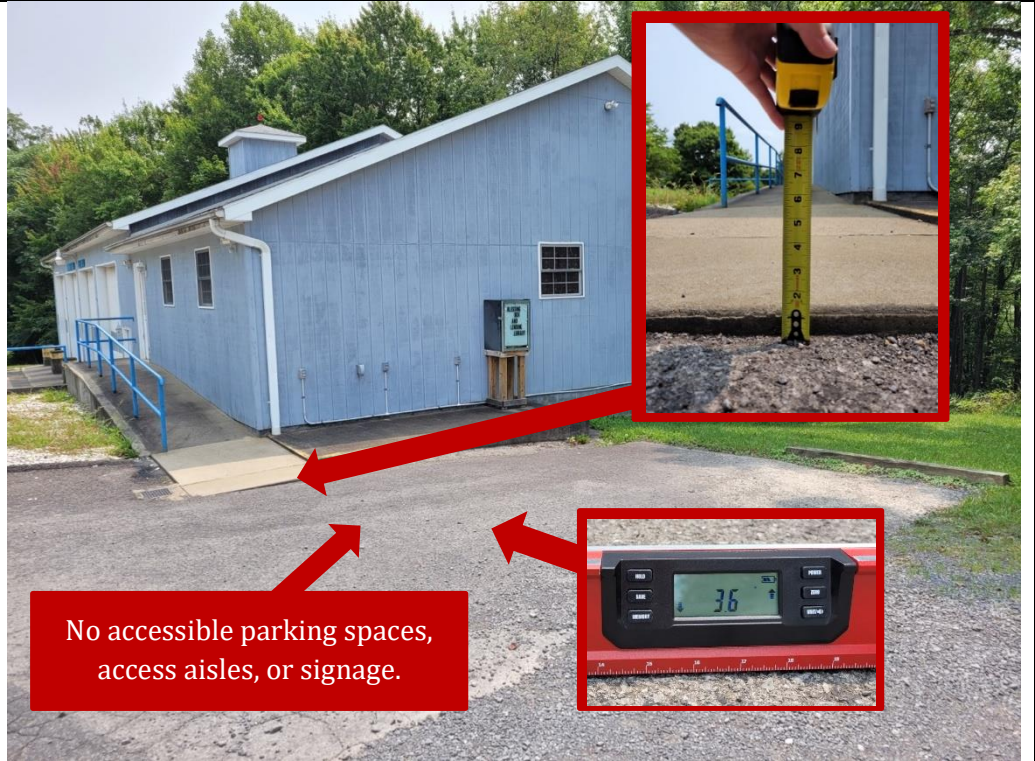
<p>Bunner's Ridge Fire Department</p>	
<p>Issue(s)</p>	<p>No accessible parking spaces are provided (502.2). The paved parking facility is not suitable for accessible parking spaces due to the excessive slope (502.2, 502.3, 502.4). There is a roughly 1-inch lipped edge at the end of the ramp (303.4). The landing at the bottom of the ramp is not level nor does it meet the length and width requirements as outlined in the ADA Standards (405.7). The landing at the top of the ramp, though level, does not meet the length and width requirements (405.7). There is no interior handrail on the ramp (405.8). There is no edge protection provided on the ramp where there is a 30" drop off (405.9).</p>

No accessible parking spaces,
access aisles, or signage.

<p>Suggestions for ADA Compliance</p>	<p>Address the issues identified or relocate the polling place to another facility that complies with ADA Standards.</p>

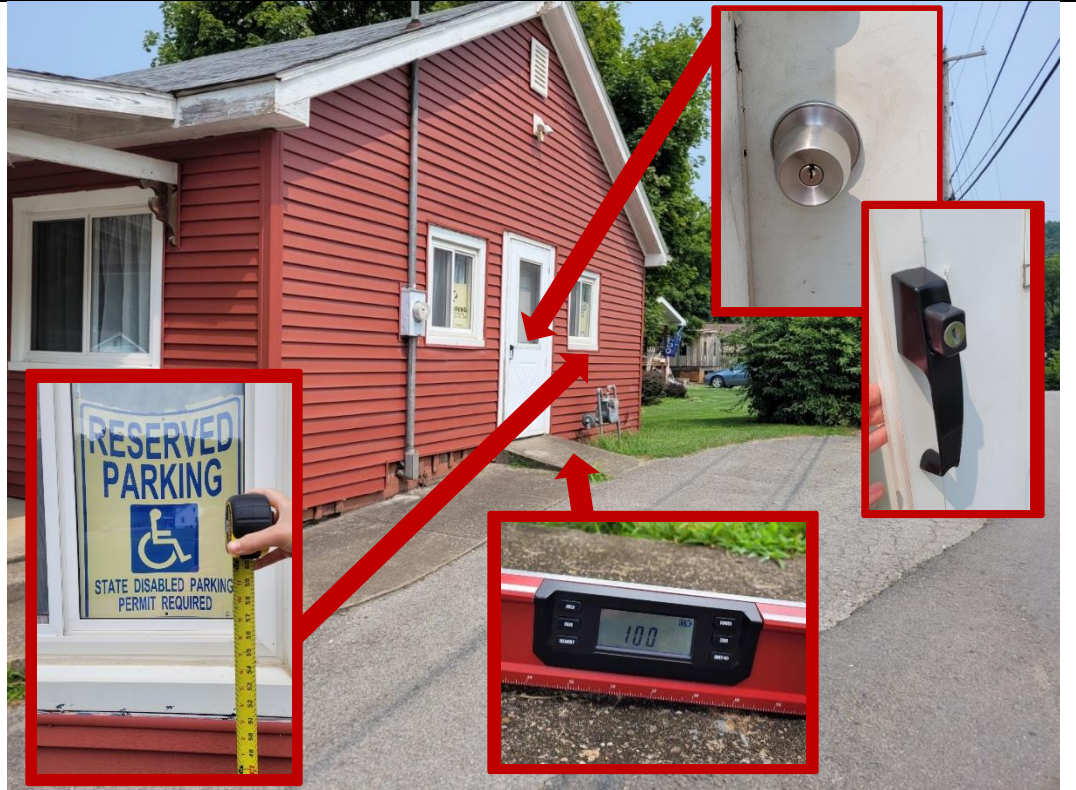
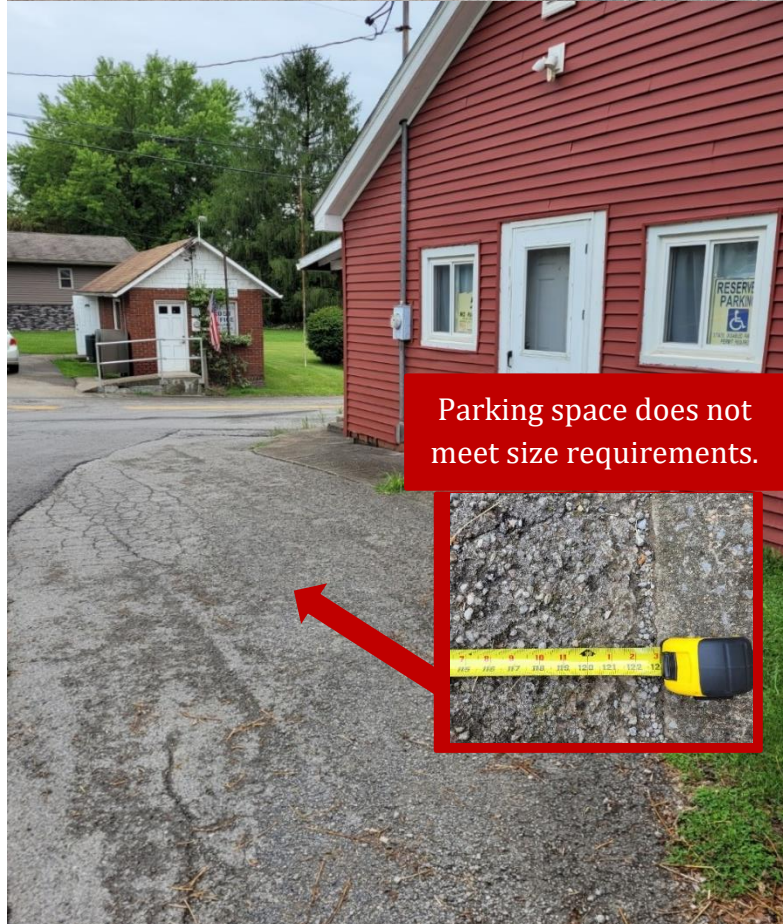
<p>Colfax Community Building</p>	
<p>Issue(s)</p>	<p>The paved area for the accessible parking space is not clearly defined (the signage displayed in the window is difficult to see and there are no markings) (502.2). The paved parking area is not wide enough to fit a parking space and access aisle to the width requirements as outlined in the ADA Standards (502.2). The door hardware is not accessible (309.4). The slope of the access ramp exceeds ADA standards; It is at a 10-degree slope when it should not exceed 4.76 degrees (405.2). The area in front of the door is not level in all directions (405.7).</p>

Parking space does not meet size requirements.

Suggestions for ADA Compliance	Since there is no paved, level parking facility located nearby and the only accessible entrances are located on a slope, it might be best to move this polling location to another facility nearby that better complies with ADA Standards.
---------------------------------------	---

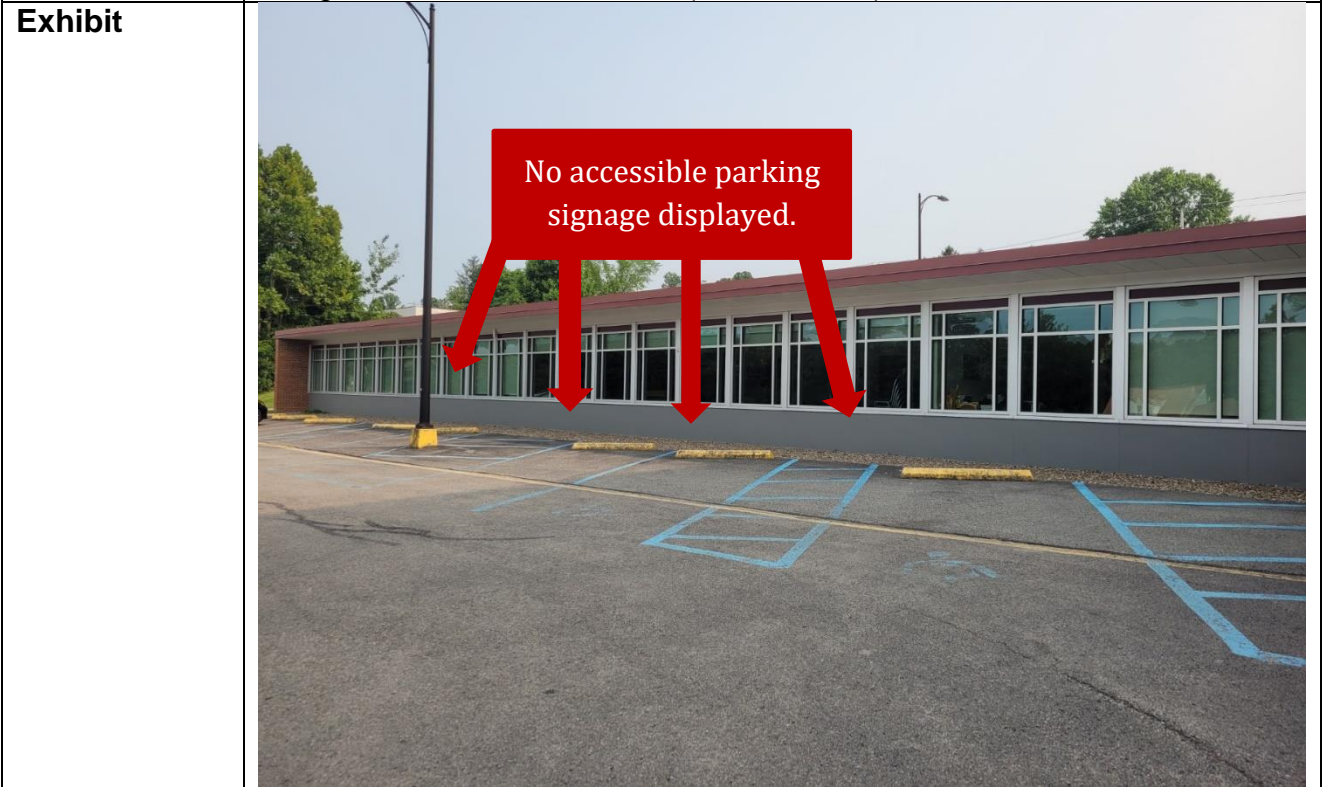
Issue(s)	There is no accessible parking signage displayed, nor is there a space designated as van accessible (502.2, 502.6).
-----------------	---

Suggestions for ADA Compliance	Install parking signage at the required height (60”) as outlined in the ADA Standards and designate a number of the spaces to be van accessible, complying with 208.2.4 as it relates to van accessible parking spaces. There are already spaces there that meet the size requirements, so simply installing the correct signage would suffice.
---------------------------------------	---

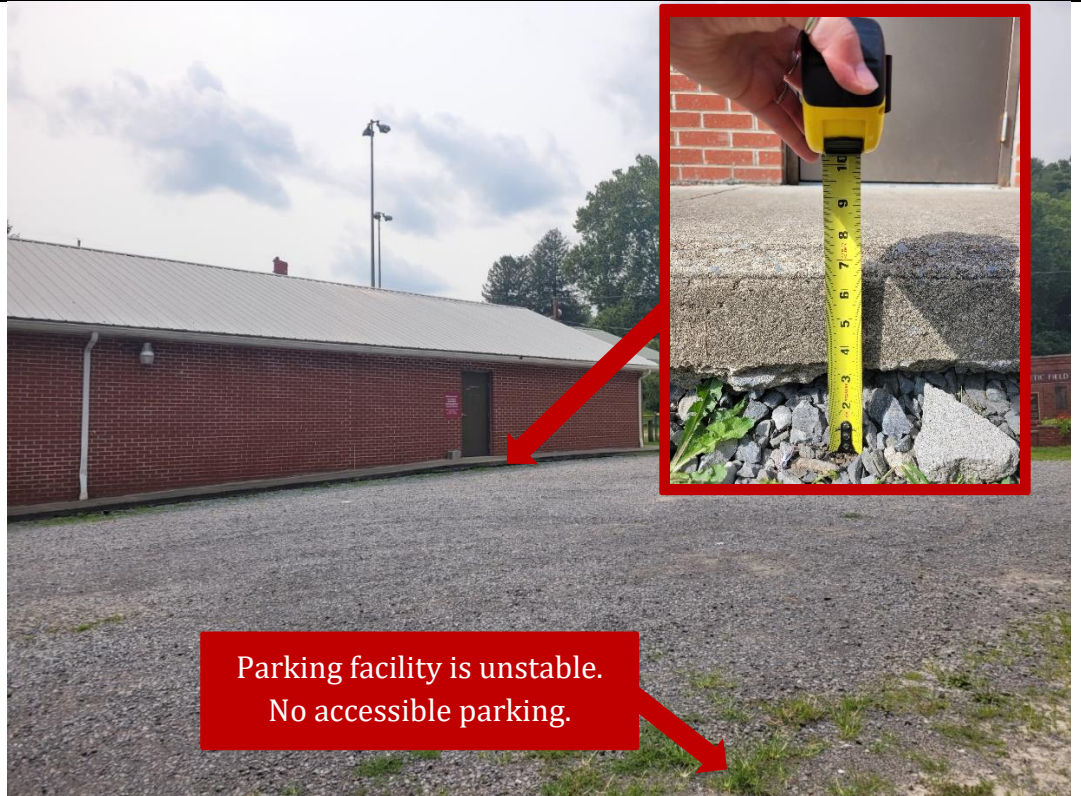
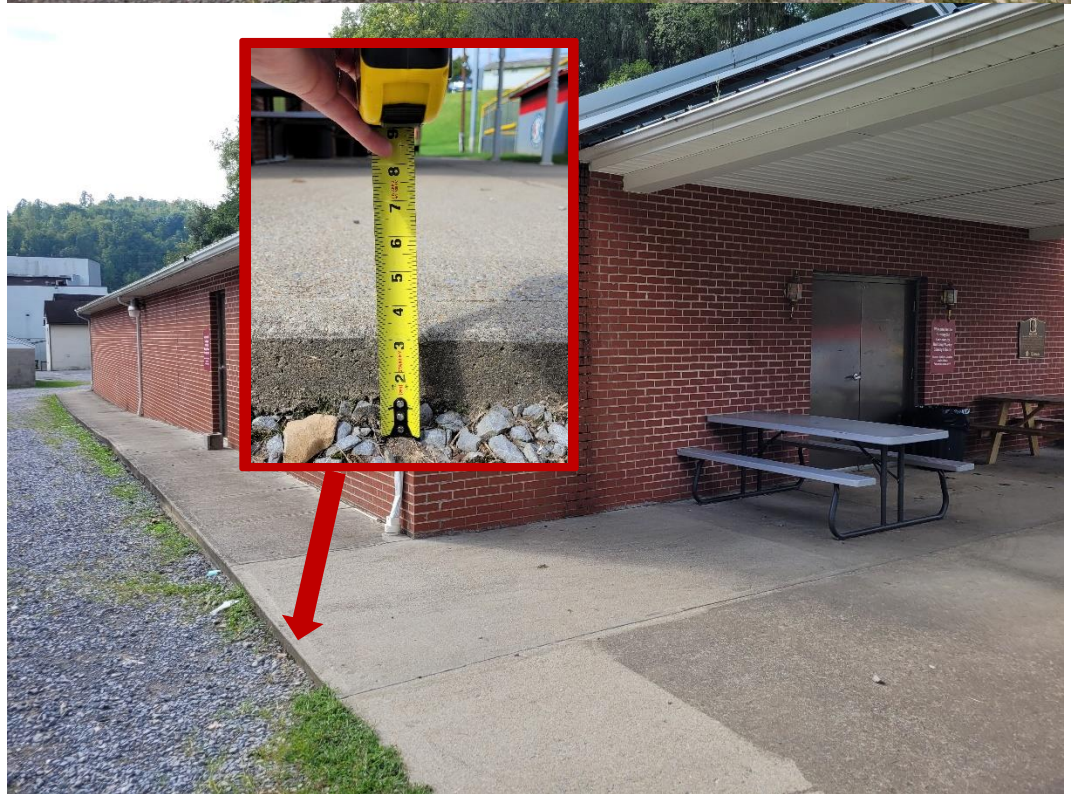
Issue(s)	The parking facility is unstable due to the loose gravel (302.1). There is no accessible parking provided (502.2). There is no access route connecting the parking facility to the entrance, due to a large curb with a step up to enter the building (206.2.2, 303.4).
-----------------	---

Parking facility is unstable.
No accessible parking.

Pave a section of the parking facility to ensure a level, firm, stable, and non-slip surface and install accessible parking spaces with access aisles

and appropriate signage, complying with ADA Standards. Designate at least one parking space to be van accessible.

Since the height of the curb (see first picture in “Exhibits”) leading to the side entrance exceeds 6”, it would be considered a ramp that would need handrails installed as well. Therefore, it may be best to utilize the back entrance for polling (see second picture provided in “Exhibits”); The height of the curb’s edge is lower than the other, which may make it easier to install a curb ramp. Handrails would not be required for this ramp.

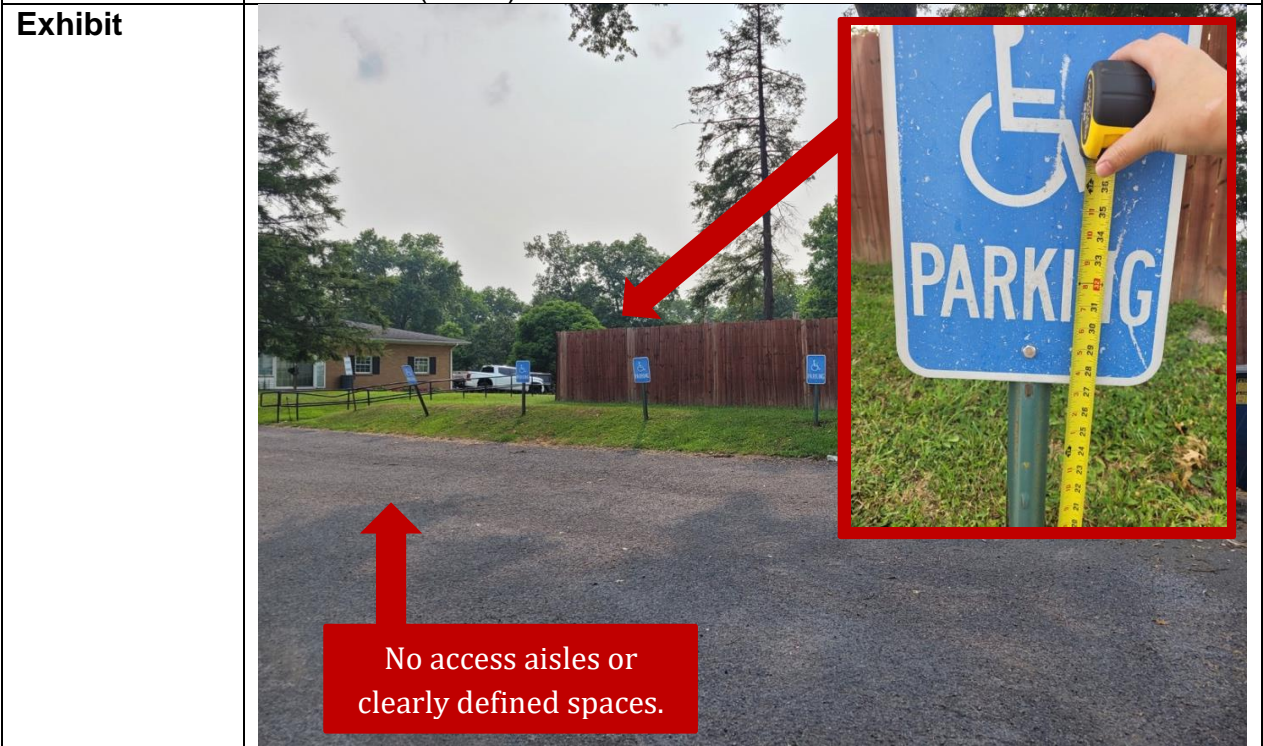
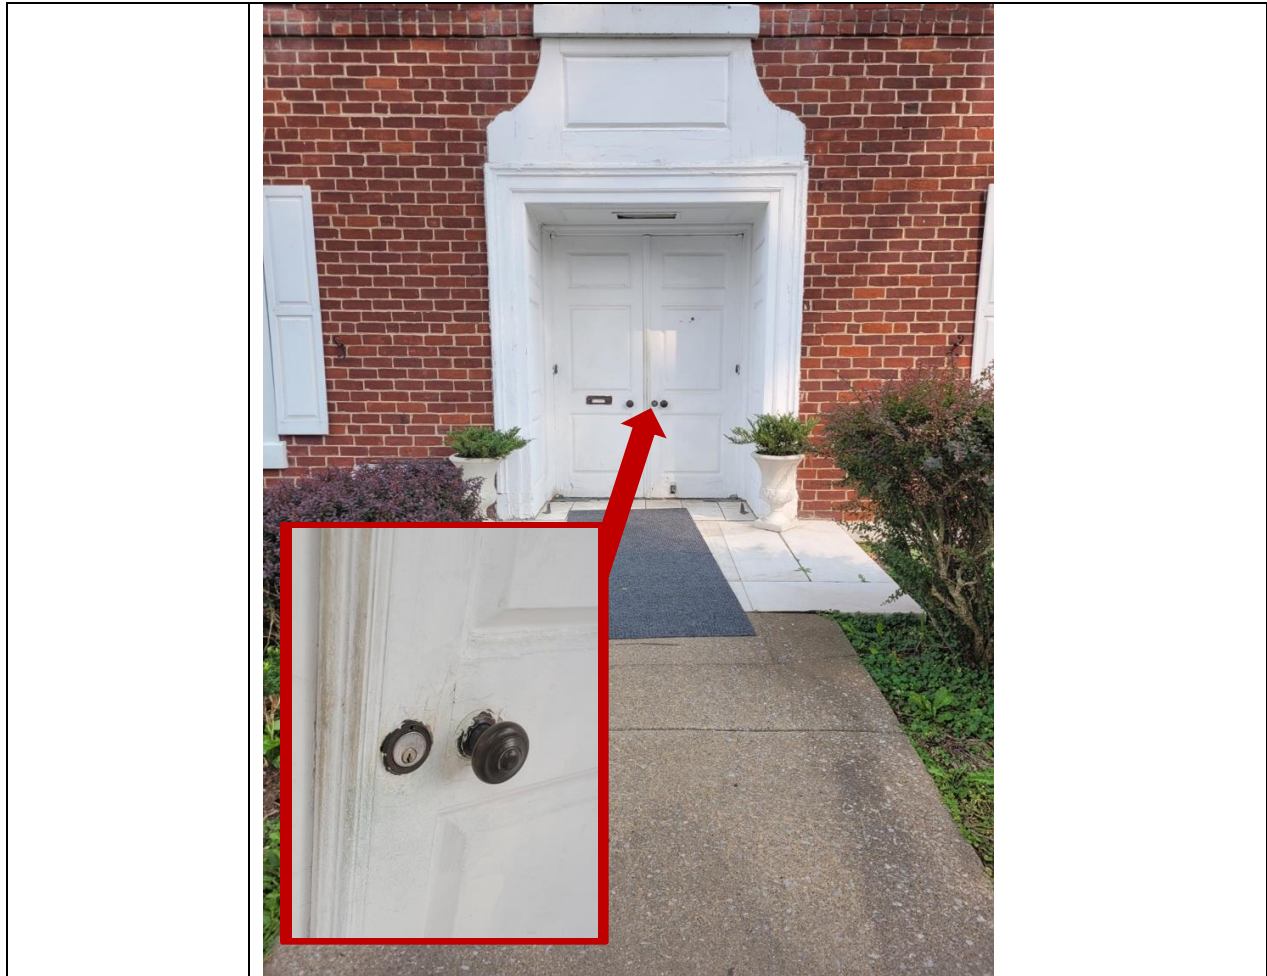
Issue(s) The existing accessible parking signage is not displayed at the proper height (502.6). There are not clearly defined access aisles for each accessible parking space (502.2, 502.3). There is no parking space designated as van accessible (502.2). The door hardware is not accessible (309.4).

<p>Suggestions for ADA Compliance</p>	<p>Replace the inaccessible door hardware with a loop, push, or pull hardware. Adjust existing parking signage to the appropriate height requirement (60”) and designate at least one space to be van accessible. Install access aisles, complying with ADA Standards 502.2.</p>
--	--

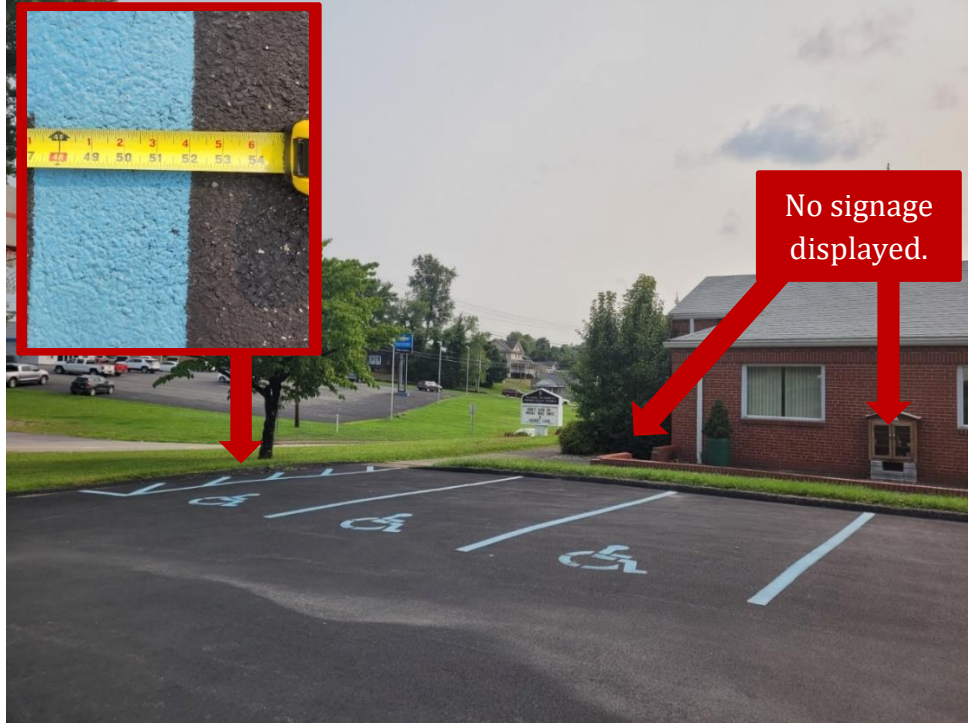
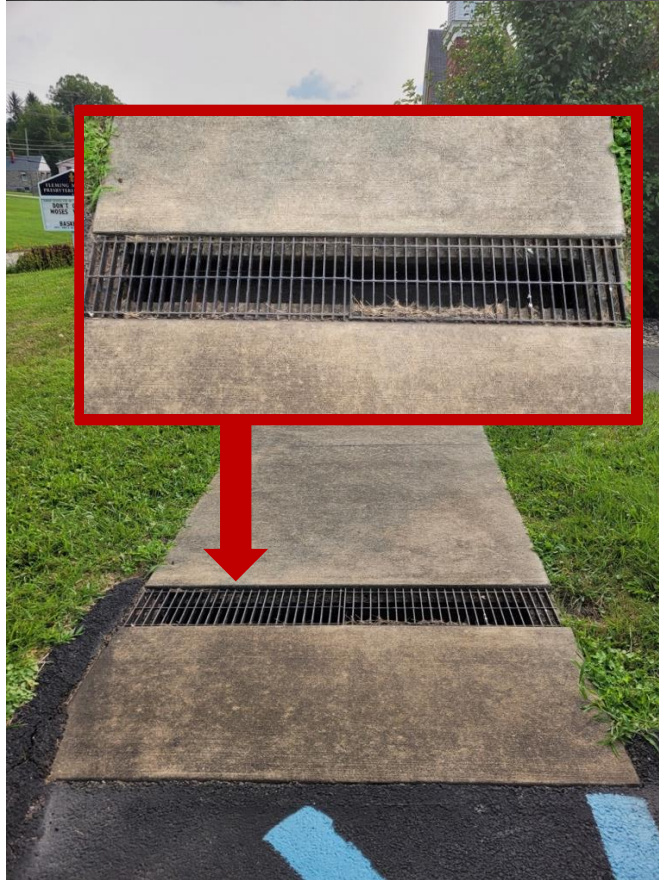
<p>Fleming Memorial Presbyterian Church</p>	
<p>Issue(s)</p>	<p>There is no accessible parking signage displayed (502.6). There is no parking space designated van accessible (502.2). The access aisle does not meet width requirements (502.2, 502.3). There are missing access aisles for 2 of the 3 parking spaces (502.3). Drain grate is obstructing the access route (302.1).</p>

No signage displayed.

Use a temporary mat to cover the drain grate or install a drain grate with smaller openings. Install parking signage to the required height (60") as outlined in the ADA Standards. Install access aisles to the

required width (at least 60”) to serve each parking space, complying with 502.3. Designate at least one space to be van accessible, ensuring it complies with the ADA Standards for van parking spaces.
--	---

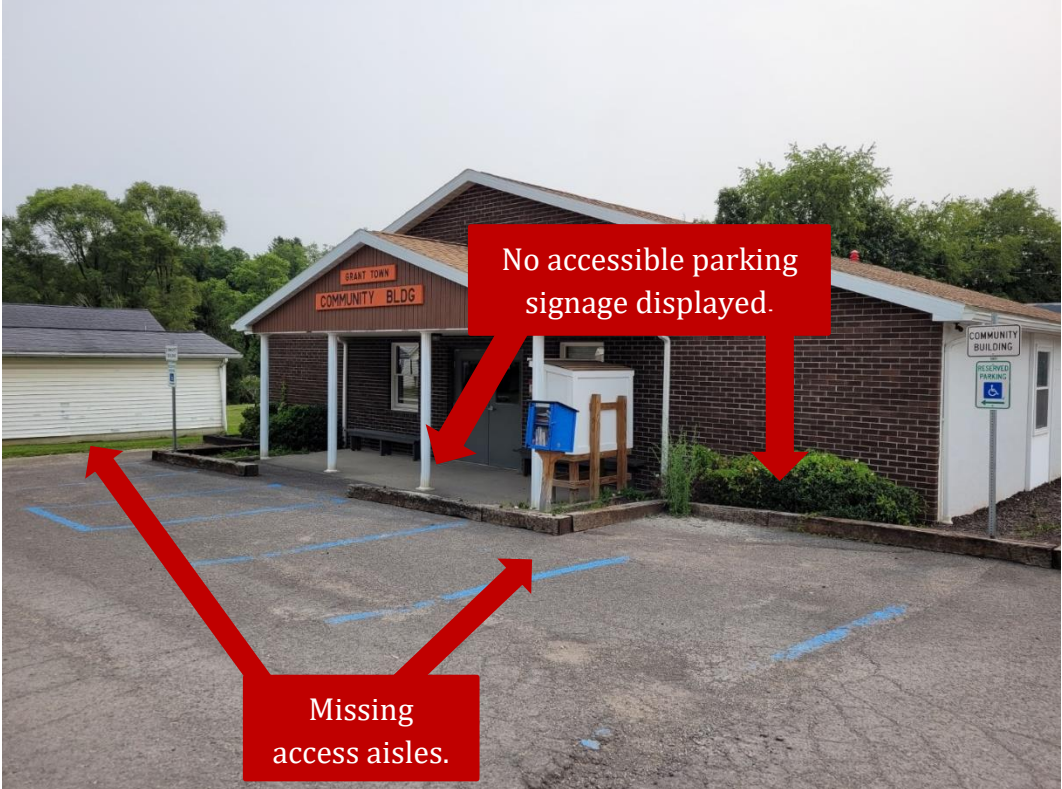
Grant Town Community Building	
Issue(s)	Accessible parking signage is missing for most of the spaces (502.6). Not all parking spaces have an access aisle attached (502.2, 502.3). There is no parking space designated as van accessible (502.2).
Exhibit

<p>The photograph shows the Grant Town Community Building, a brick structure with a sign that reads "GRANT TOWN COMMUNITY BLDG". In front of the building is a paved parking lot with several blue-painted accessible parking spaces. Red arrows point to specific areas: one points to a sign that says "No accessible parking signage displayed.", and another points to a space with a red box that says "Missing access aisles." A third arrow points to a space with a sign that says "COMMUNITY BUILDING RECESSED PARKING".</p>
Suggestions for ADA Compliance	Install access aisles to serve each accessible parking space. Install parking signage to the required height (60”), designating at least one space to be van accessible.

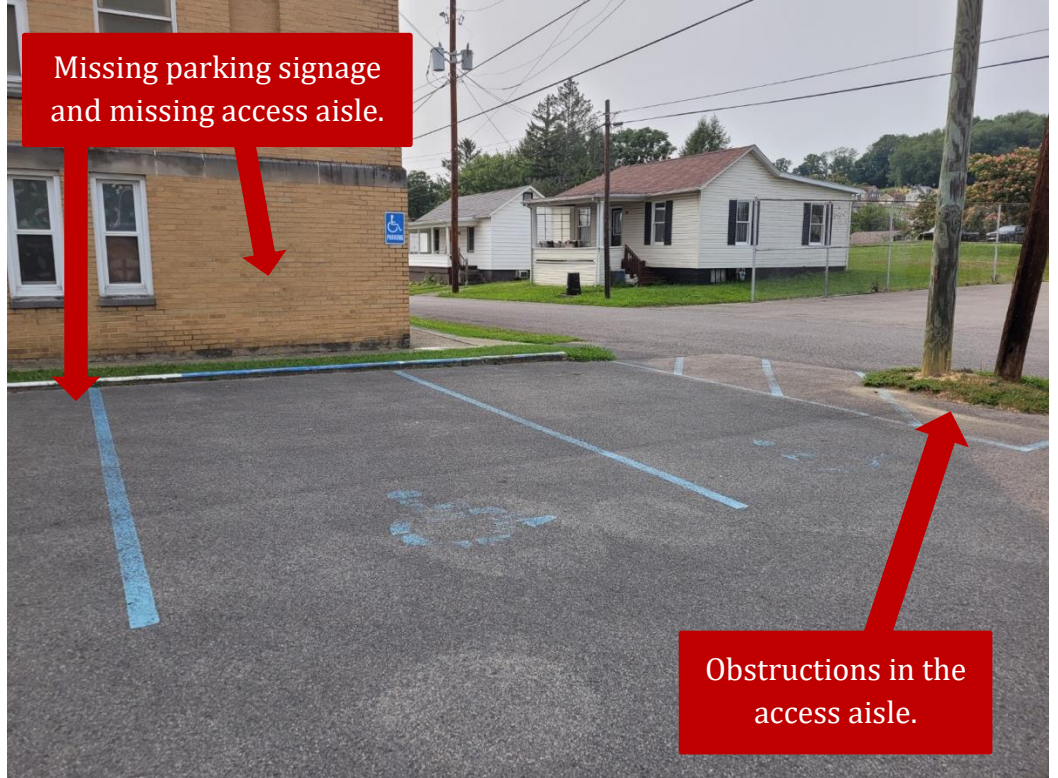
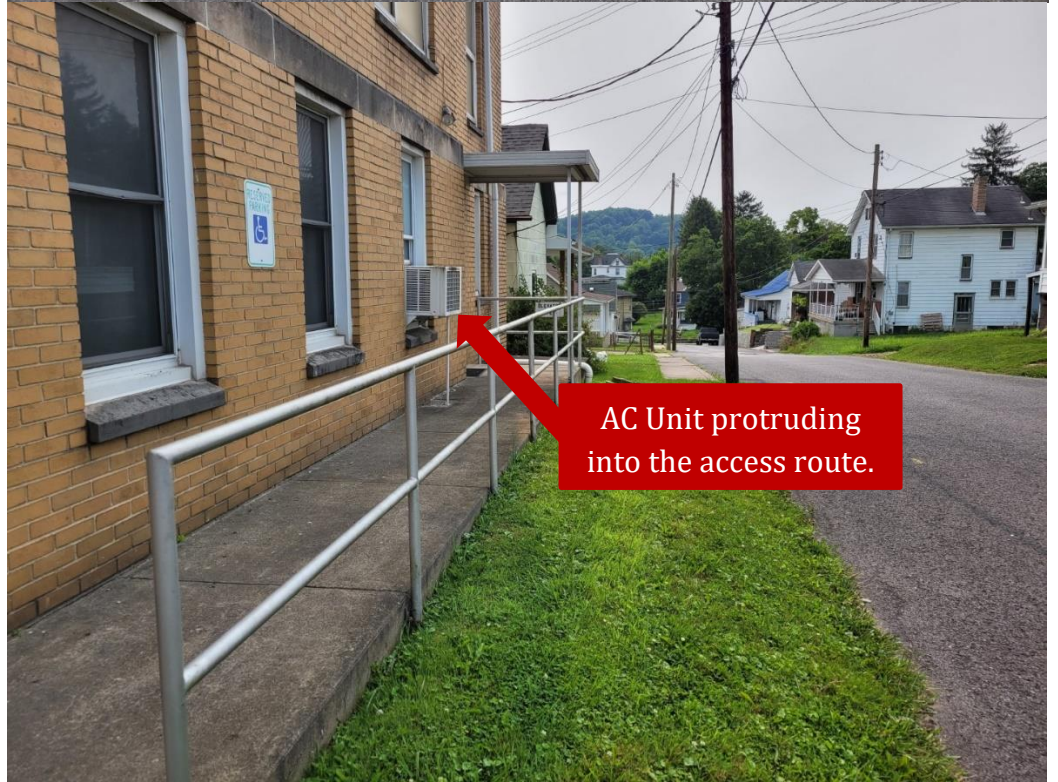
Highland Ave UMC	
Issue(s)	There is missing signage for some of the accessible parking spaces (502.6). The telephone pole and patch of grass is protruding into the access aisle (502.2, 502.3). The other parking space is missing an access aisle (502.2, 502.3). Window AC Unit is protruding into the access route (307.1, 307.2).

Relocate the window AC unit so that it does not protrude into the access route. Install parking signage where needed to the required height (60") as outlined in the ADA standards, designating at least one space to be van accessible. Relocate the access aisle so there are no obstructions.

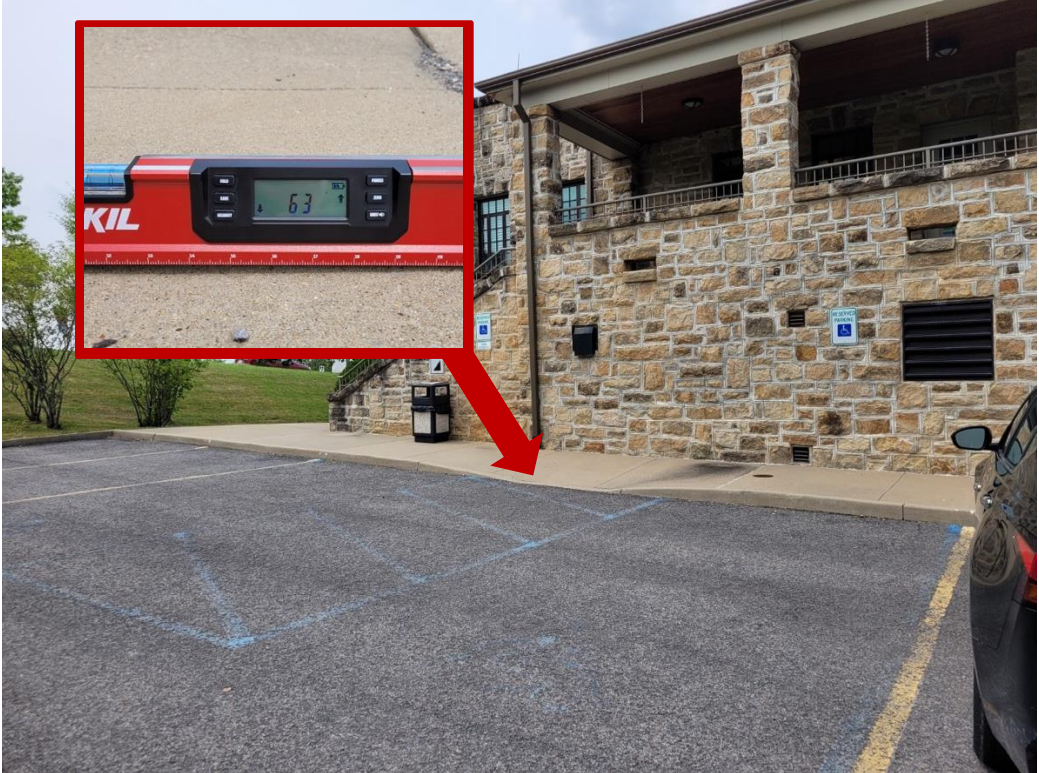
<p>Marion County Convention Center</p>	
<p>Issue(s)</p>	<p>The slope of the curb ramp exceeds ADA Standards; It is 6.3 degrees, and it should not exceed 4.76 degrees (405.2).</p>

<p>Suggestions for ADA Compliance</p>	<p>Adjust the existing curb ramp to comply with ADA Standards as it relates to slope.</p>

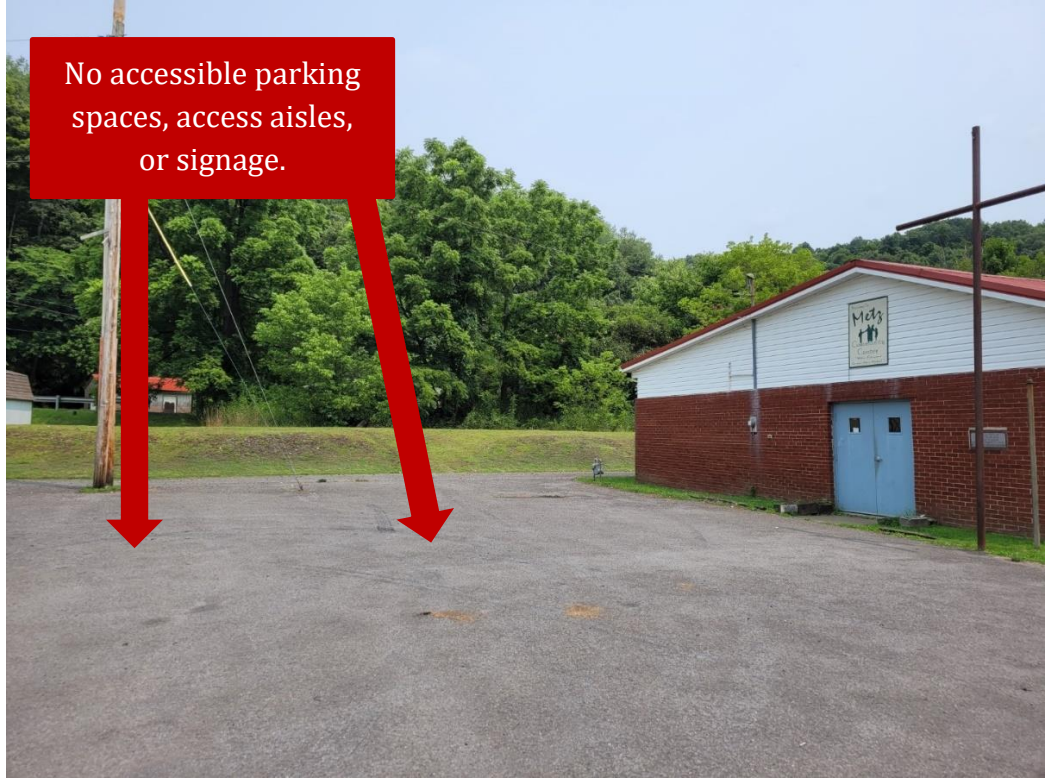
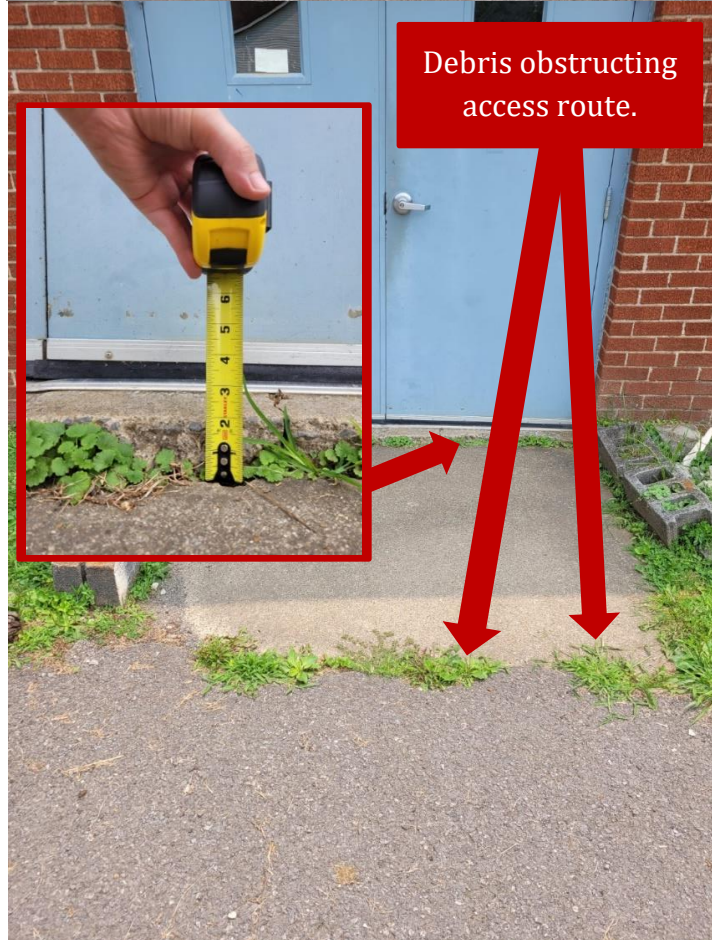
<p>Metz Community Center</p>	
<p>Issue(s)</p>	<p>There is no accessible parking provided (502.2). There is debris (patches of grass and cracks in sidewalk) obstructing the access route to entry (302.1). There is a 2-inch lipped edge at the entrance door (303.4).</p>

Suggestions for ADA Compliance	Install at least one accessible parking space, designated to be van accessible with appropriate signage and an access aisle. Clear the paved area of all debris (grass patches) to ensure a stable surface. Bevel the lipped edge at the door or utilize a temporary wedge. Repair sidewalk or utilize mats for the access route.
---------------------------------------	---

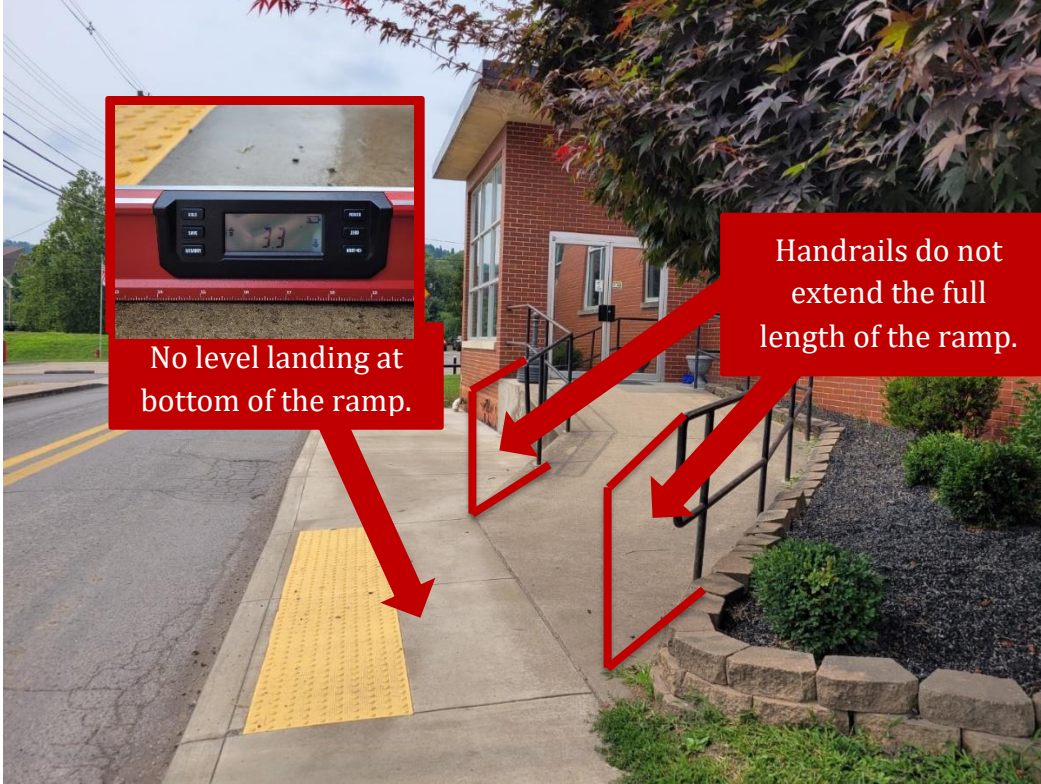
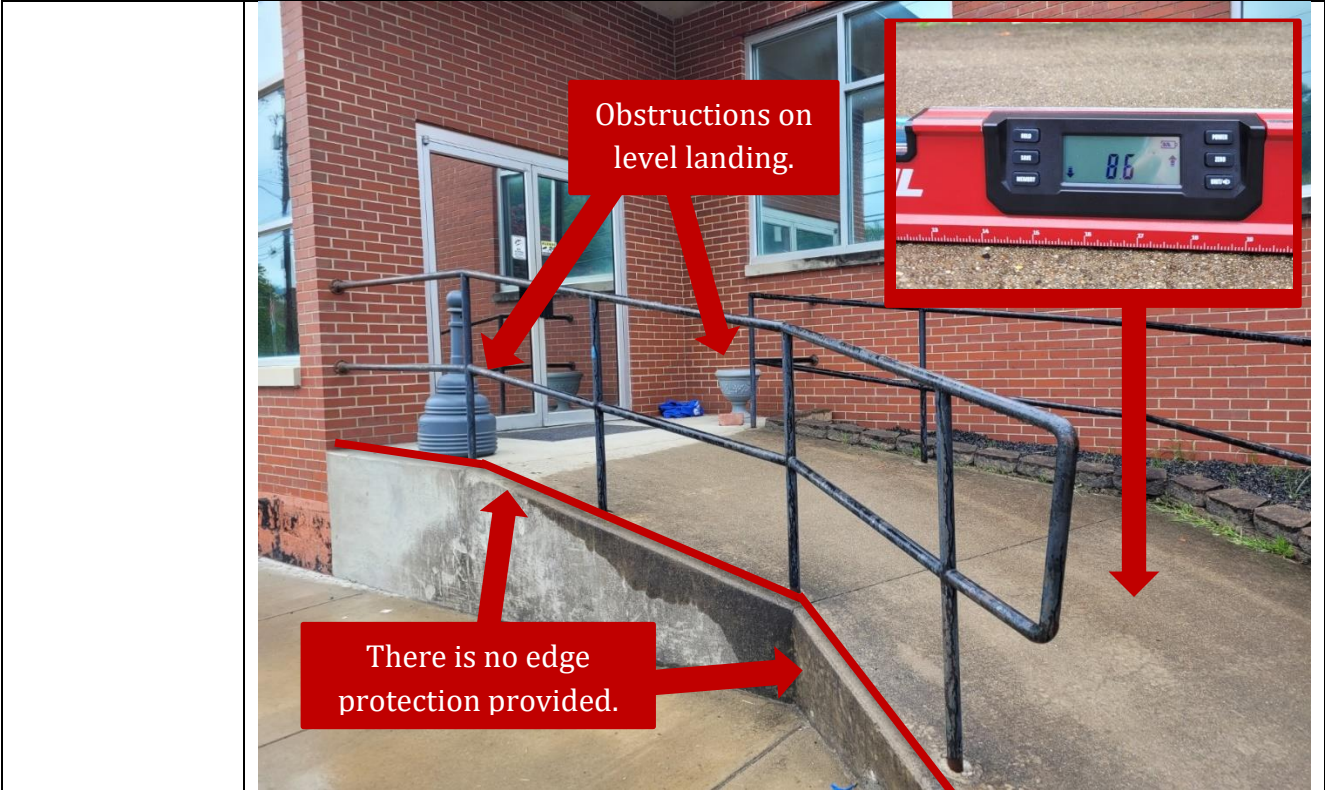
Issue(s)	Handrails are not extended to the bottom of the ramp (505.10.1). There is no edge protection on the ramp (405.9). The slope of the ramp exceeds ADA Standards; The slope runs 8.5-9.0 degrees but should not exceed 4.76 degrees (405.2). There is not a level landing provided at the bottom of the ramp (405.7). There is no accessible parking or passenger drop-off area provided (502.2).
-----------------	--

<p>The photograph shows a concrete ramp leading to a brick building. A red callout box at the top left shows a close-up of a level sensor on the ramp surface, with a red arrow pointing to the ramp's end. A red callout box at the bottom left points to the end of the ramp, stating "No level landing at bottom of the ramp." A red callout box on the right side points to the handrails, stating "Handrails do not extend the full length of the ramp." The ramp has a yellow tactile strip at the bottom and a black metal handrail on the right side.</p>
----------------	---

Suggestions for ADA Compliance	Install handrail extensions and edge protection on the ramp. Ensure the ramp has a level landing, measured 60" by 60", provided at the bottom where it meets the curb ramp. Though there is still a 60" by 60" clearance on the level landing at the top of the ramp, the debris could cause obstruction to entry and should be removed.
---------------------------------------	--

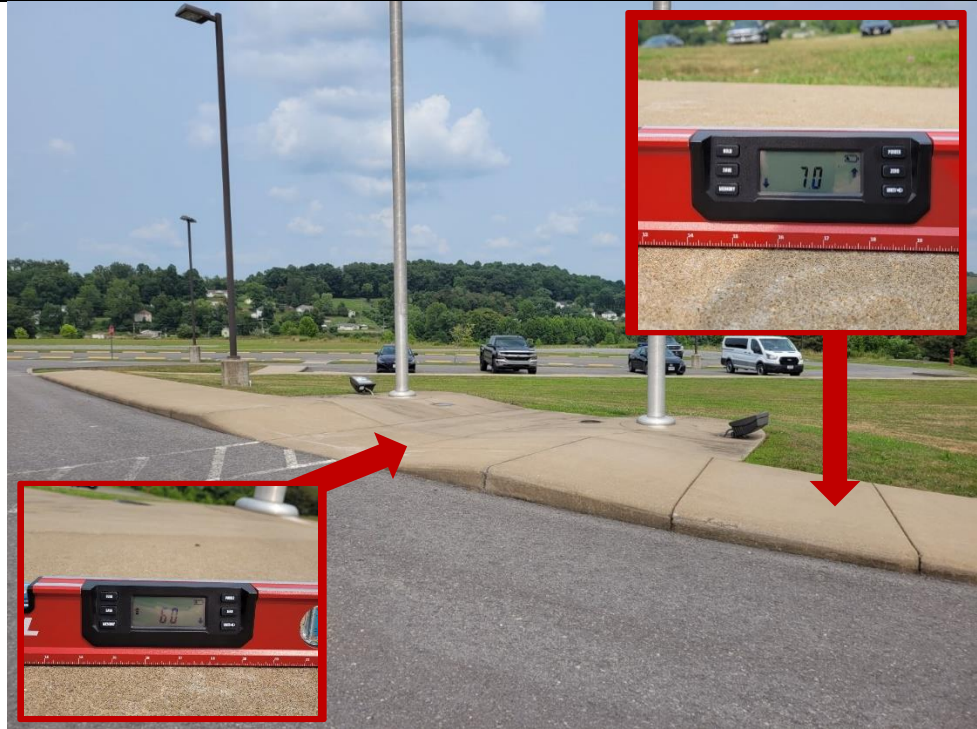
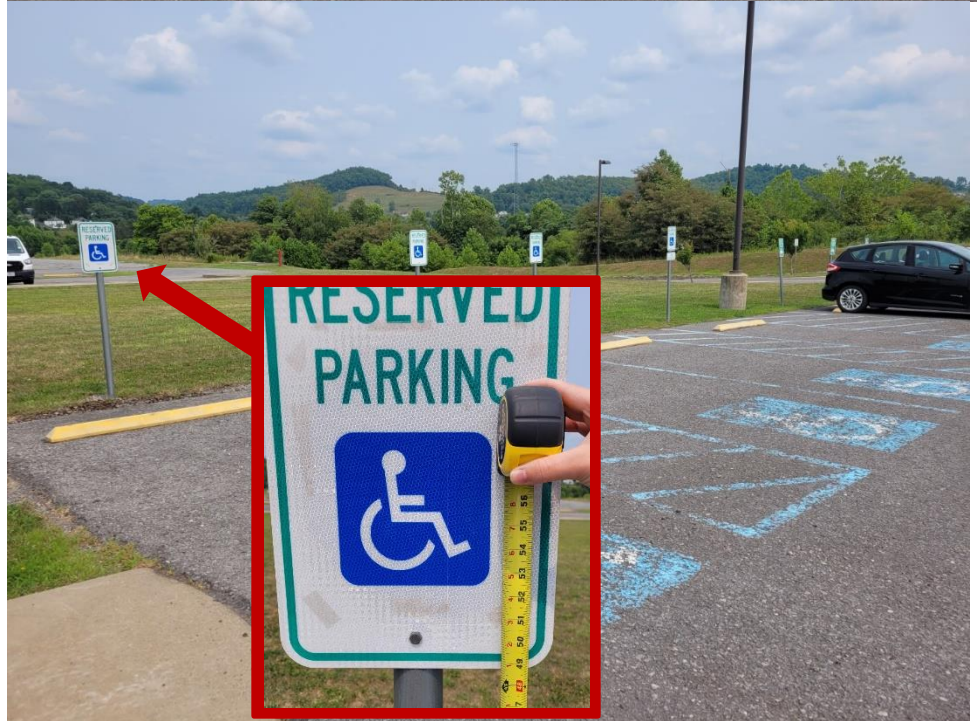
<p>National Guard Armory</p>	
<p>Issue(s)</p>	<p>The slope of the access route exceeds ADA Standards (403.3). The existing parking signage is not displayed at the proper height (502.6).</p>

Adjust the existing parking signage to the minimum height required in the ADA Standards (60"). Utilize another entrance that is accessible or install a temporary parking/passenger drop-off area in front of the main entrance to avoid the sloped access route from the accessible parking facility.

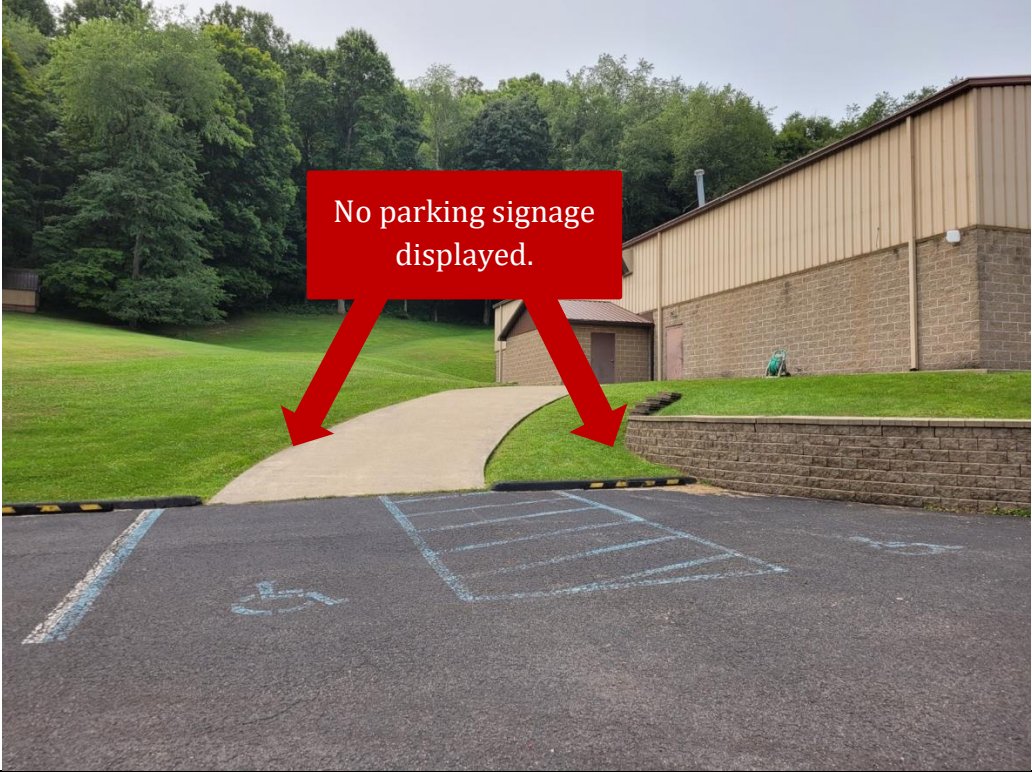
Issue(s)	There is no accessible parking signage displayed (502.6). No accessible space is designated as van accessible (502.2).
Exhibit

Suggestions for ADA Compliance	Install parking signage where needed to the required height (60") as outlined in the ADA standards, designating at least one space to be van accessible.
