2023 Polling Site Accessibility Report: Marion County, WV

On August 1 and 2, 2023, a DRWV Advocate completed exterior accessibility monitoring of all precincts in Marion County and this report contains our findings. The following ADA codes referenced below are the most common issues noted in this county.

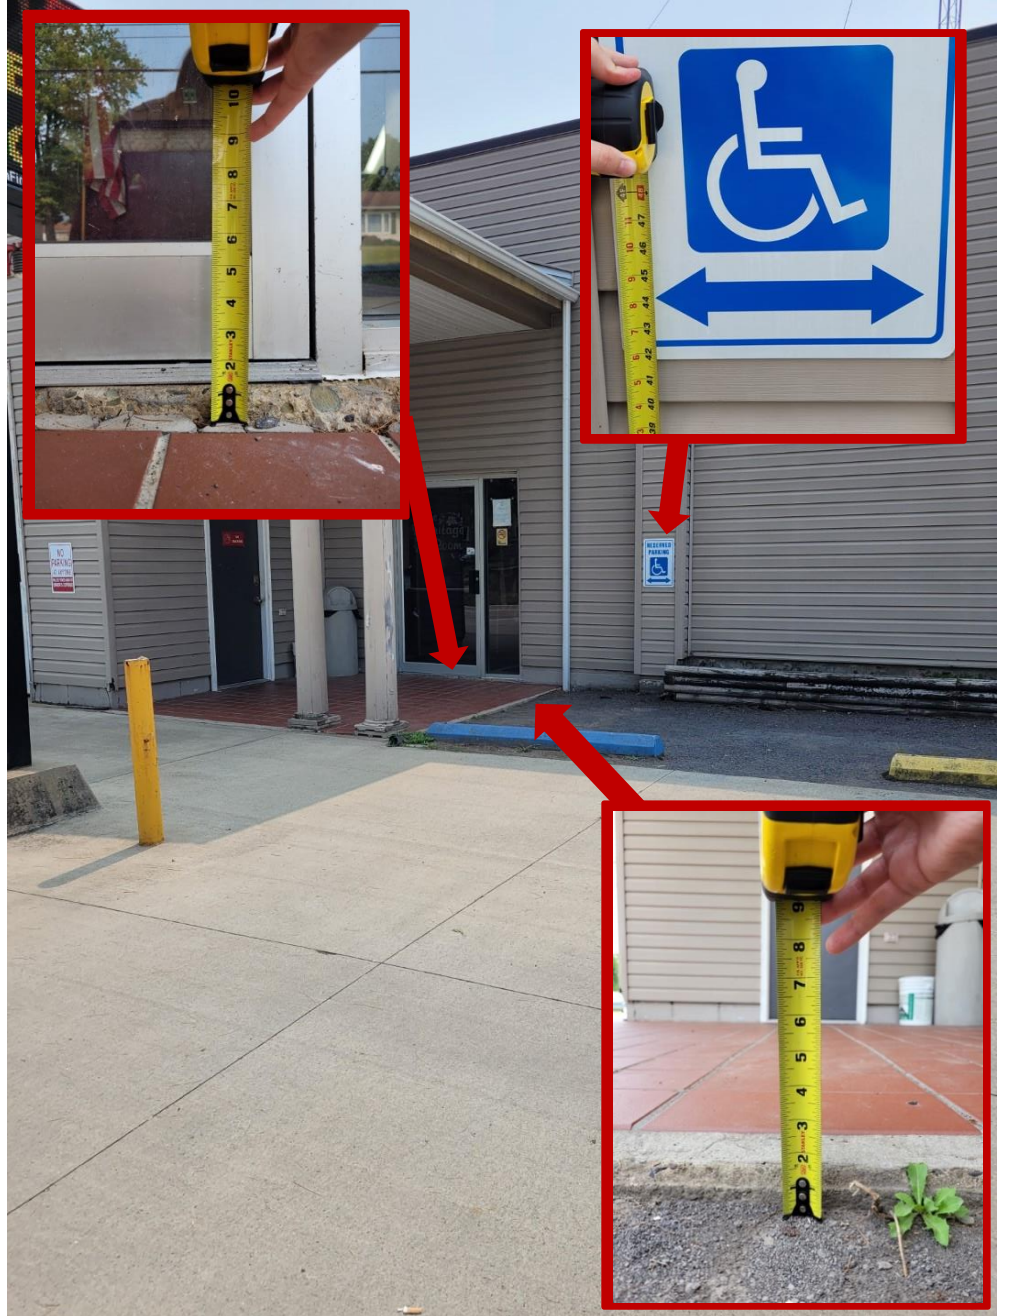
<p>Pleasant Valley VFD</p>	
<p>Issue(s)</p>	<p>The existing parking signage is not displayed at the proper height (502.6). The accessible parking space and access aisle is not clearly defined (502.2). There is a 1½ -inch lipped edge on the landing before the door, and a 1-inch lipped edge at the door (303.4).</p>

Bevel the lipped edges or install temporary wedges and/or mats to make the access route and entrance accessible. Adjust the existing signage to meet the minimum height required by the ADA Standards (60"). Clearly define the accessible parking space and access aisle by using painted lines, traffic cones, etc.

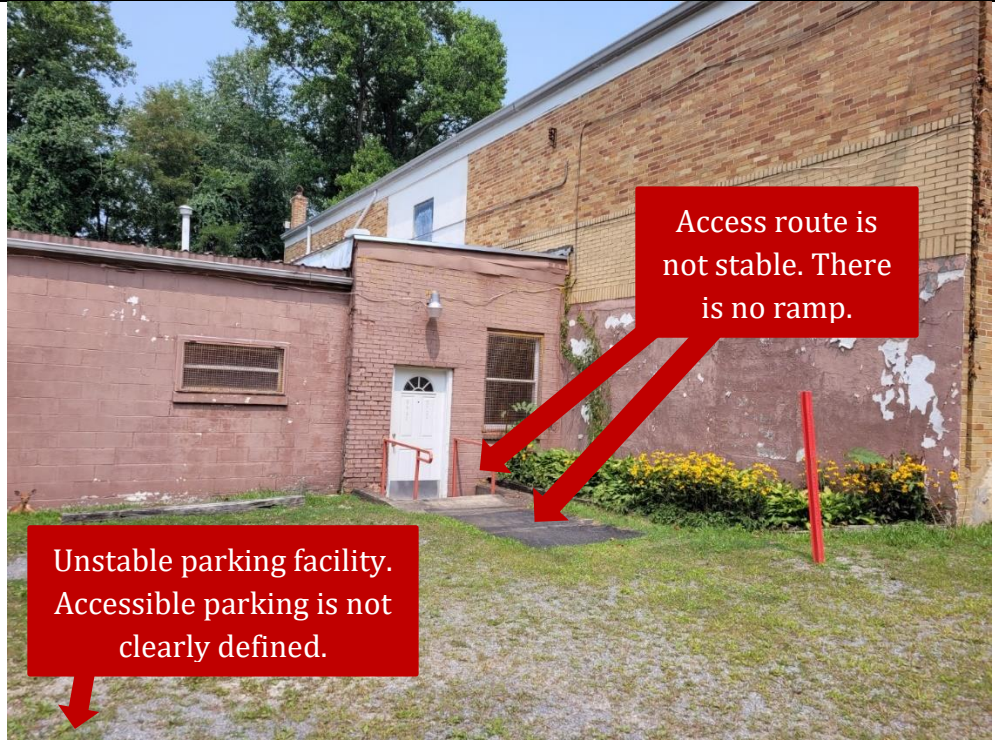
Quiet Dell Community Building	
Issue(s)	The parking facility is not stable (302.1, 502.4). The existing accessible parking signage is not visible or legible from the parking facility (502.6). The accessible parking spaces are not clearly defined (502.2, 502.3.3). Both entrances have unstable access routes (302.1). One entrance (labeled as the main entrance – white door) has only stairs and no ramp, inaccessible door hardware, and a lipped edge at the door threshold (405.1, 309.4, 303.4). The other entrance has no outer door hardware (309.4).
Exhibit

Access route is not stable. There is no ramp.

Unstable parking facility. Accessible parking is not clearly defined.

Suggestions for ADA Compliance	Address the issues identified or relocate the polling place to another facility that complies with ADA Standards.

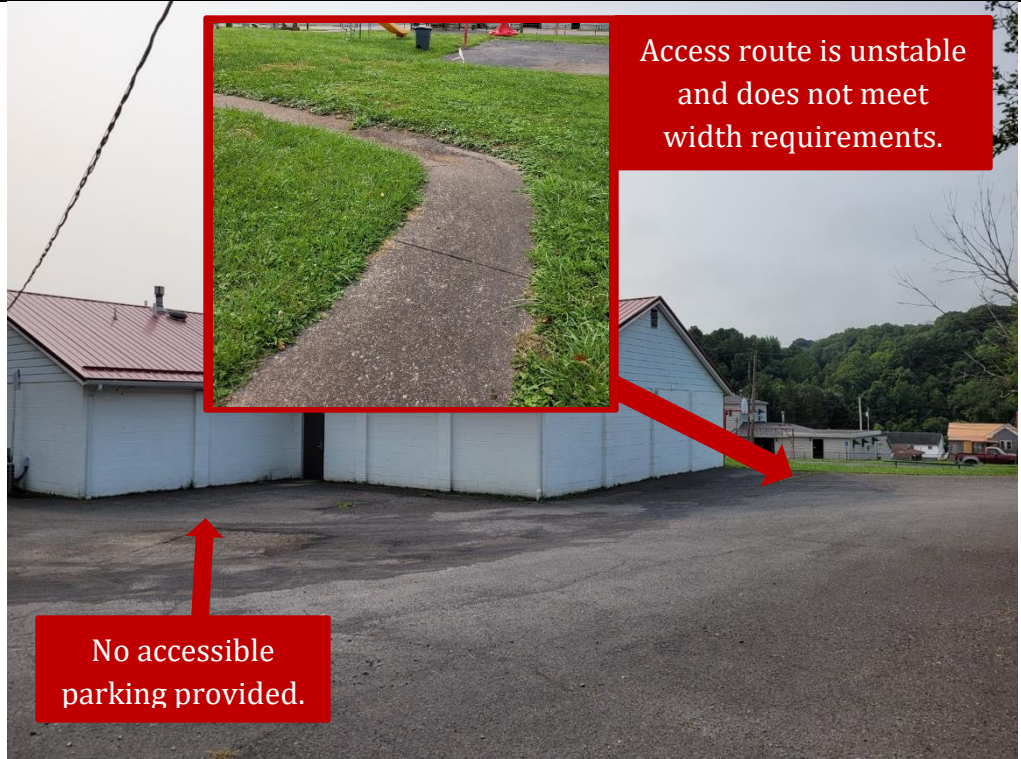
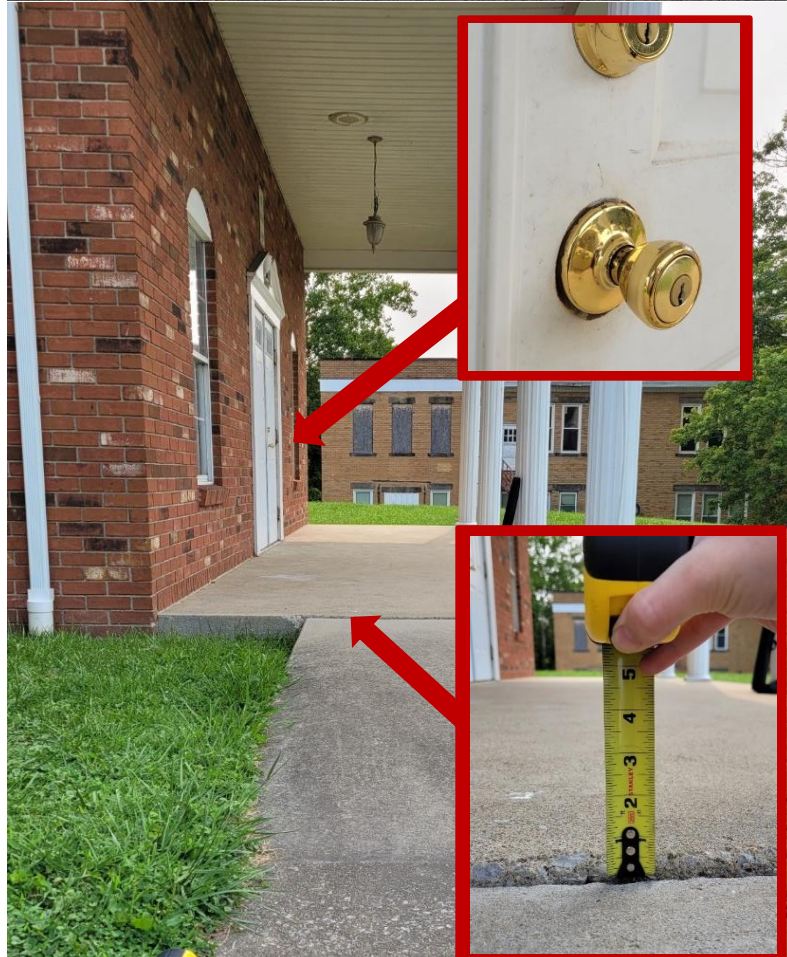
Rivesville Community Building	
Issue(s)	No accessible parking is provided (502.2). Grass is overgrowing on portions of the access route, causing it to not meet width requirements (302.1, 403.5.1). There is a ½-inch crack in the pavement on the access route (303.4). The door hardware is inaccessible (309.4).

Suggestions for ADA Compliance	Replace the inaccessible door hardware with a loop, push, or pull hardware. Install at least one van accessible parking space with an access aisle and appropriate signage. Utilizing mats may be an option to extend the width of the access route and cover the crack in the sidewalk, so long as they form a stable surface.
---------------------------------------	---

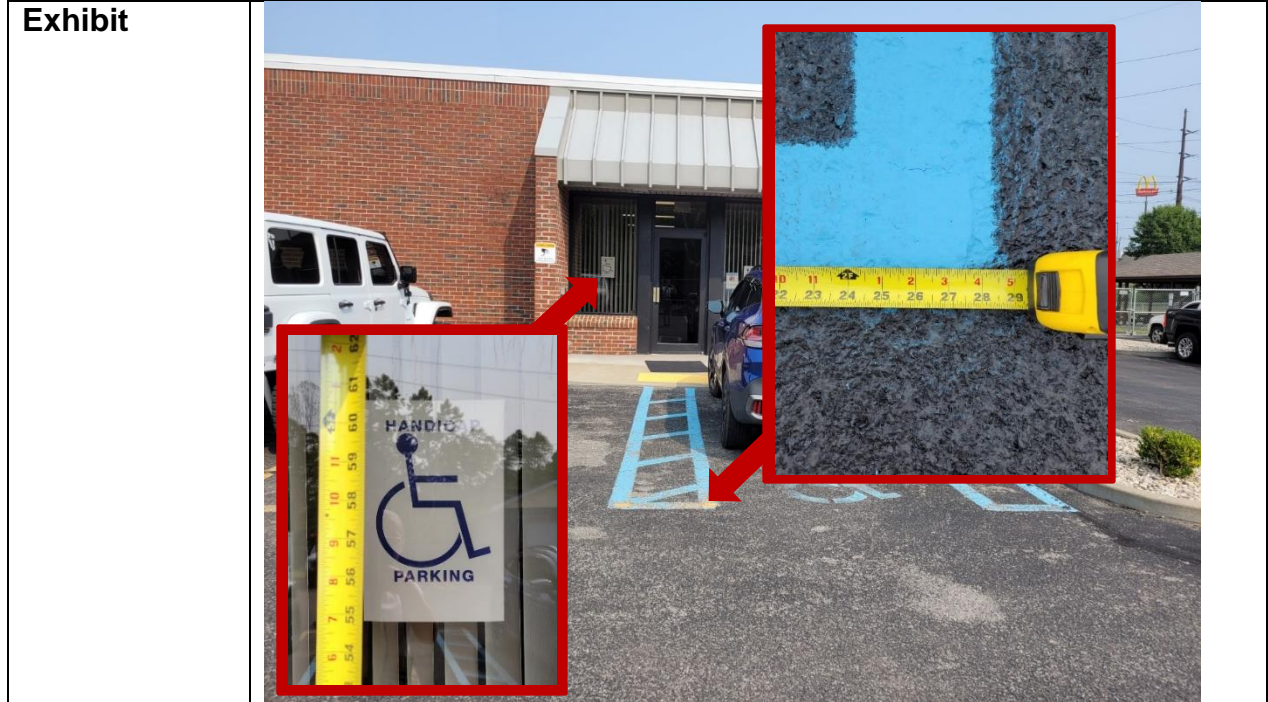
Issue(s)	The access aisle does not meet width requirements (502.2, 502.3). The existing parking signage is not displayed at the proper height and is not clearly visible from the parking facility (displayed inside the window) (502.6). There is no parking space designated as van accessible (502.2).
-----------------	--

Suggestions for ADA Compliance	Adjust existing parking signage to the minimum height required in the ADA Standards (60”) and relocate it outside the window to be easily visible to a driver. Designate at least one parking space to be van accessible with appropriate signage. Extend the existing access aisle to be at least 60” in width.
---------------------------------------	--

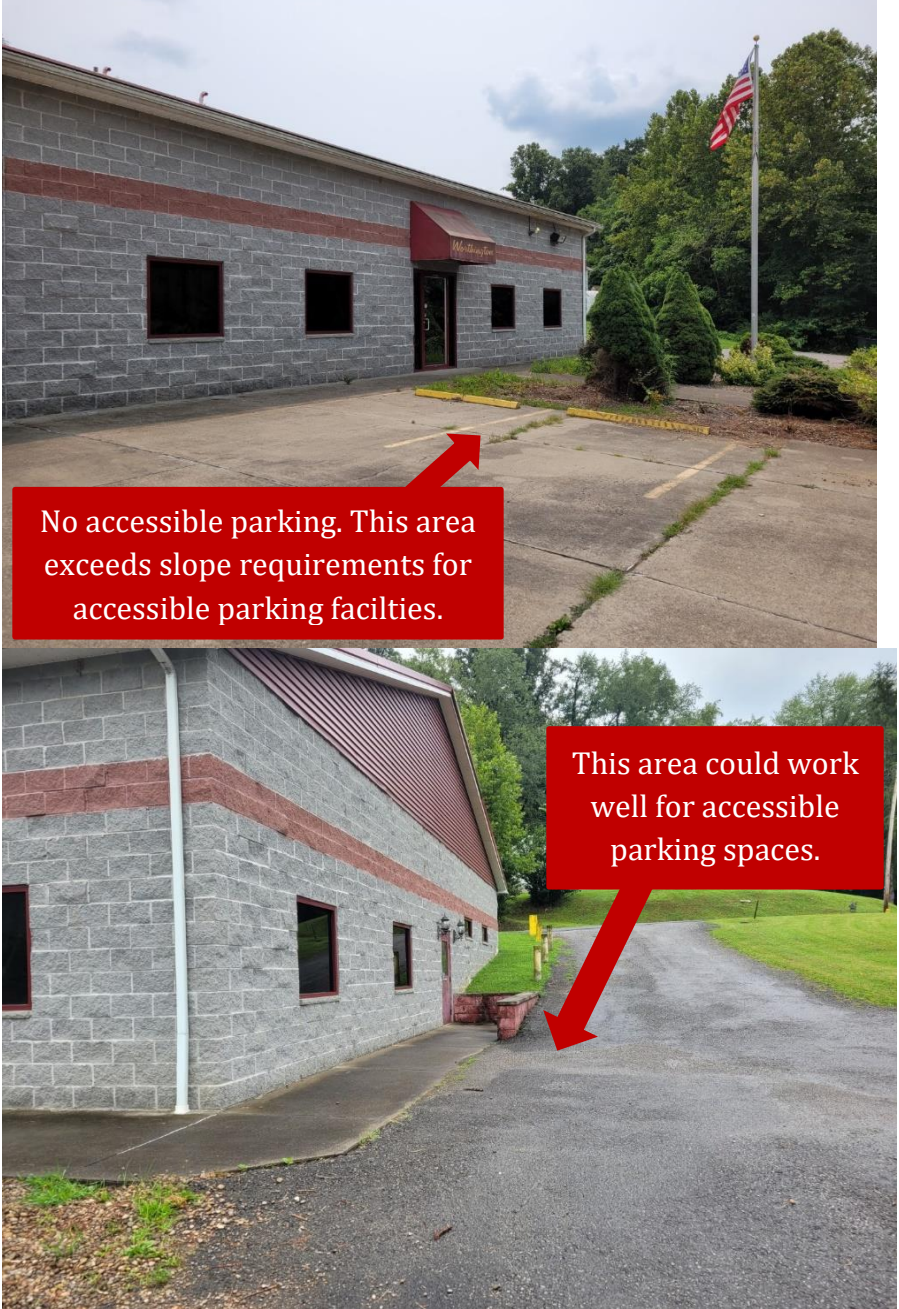
<p>Worthington VFD</p>	
<p>Issue(s)</p>	<p>There is no accessible parking provided (502.2).</p>

<p>Suggestions for ADA Compliance</p>	<p>Since the paved parking area in front of the building is on a slope that exceeds ADA Standards, utilize the paved area along the right side of the building for an accessible parking facility. Install at least one van accessible parking space with an access aisle and appropriate signage. Make sure to install signage directing voters to the accessible parking area and entrance.</p>
