2023 Polling Site Accessibility Report: Wetzel County, WV

On October 11, 2023, a DRWV Advocate completed exterior accessibility monitoring of all precincts in Wetzel County and this report contains our findings. The following ADA codes referenced below are the most common issues noted in this county.

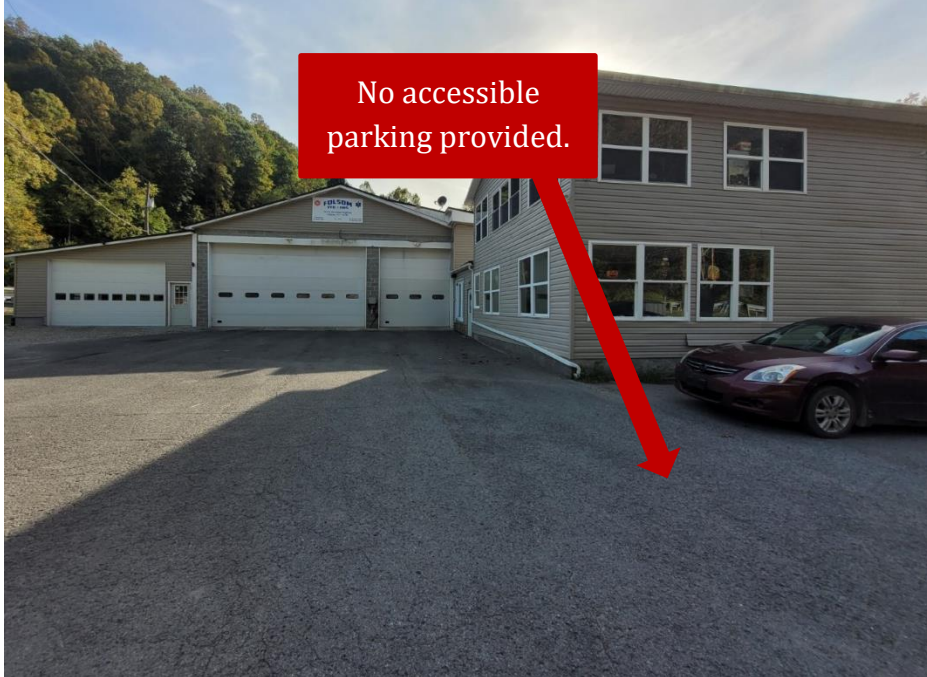
<p>Folsom Fire Department</p>	
<p>Issue(s)</p>	<p>No accessible parking spaces provided (502.2).</p>
<p>Exhibit</p>

<p>Suggestions for ADA Compliance</p>	<p>Install at least one van accessible parking space with adjoining access aisle and appropriate signage.</p>

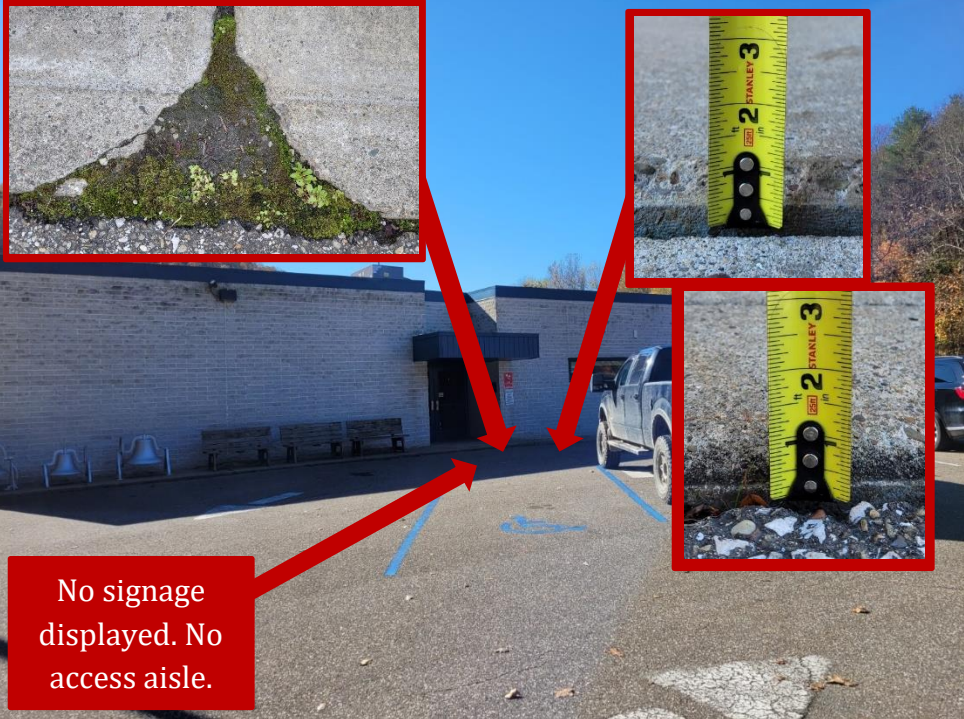
<p>Long Drain Elementary School</p>	
<p>Issue(s)</p>	<p>No accessible parking signage displayed (502.6). No access aisles provided (502.2, 502.3). There is a ½ inch opening in the pavement, a 1 inch lipped edge on the sidewalk, and a damaged area on the accessible route causing obstructions (302.1, 303.4).</p>

<p>No signage displayed. No access aisle.</p>
<p>Suggestions for ADA Compliance</p>	<p>Utilize mats to cover the damaged area, lipped edge, and opening in pavement on the accessible route to ensure a stable, firm, and non-slip surface. Install an access aisle to adjoin the accessible parking space and parking signage, adhering to ADA Standards. Designate the accessible parking space to be van accessible.</p>

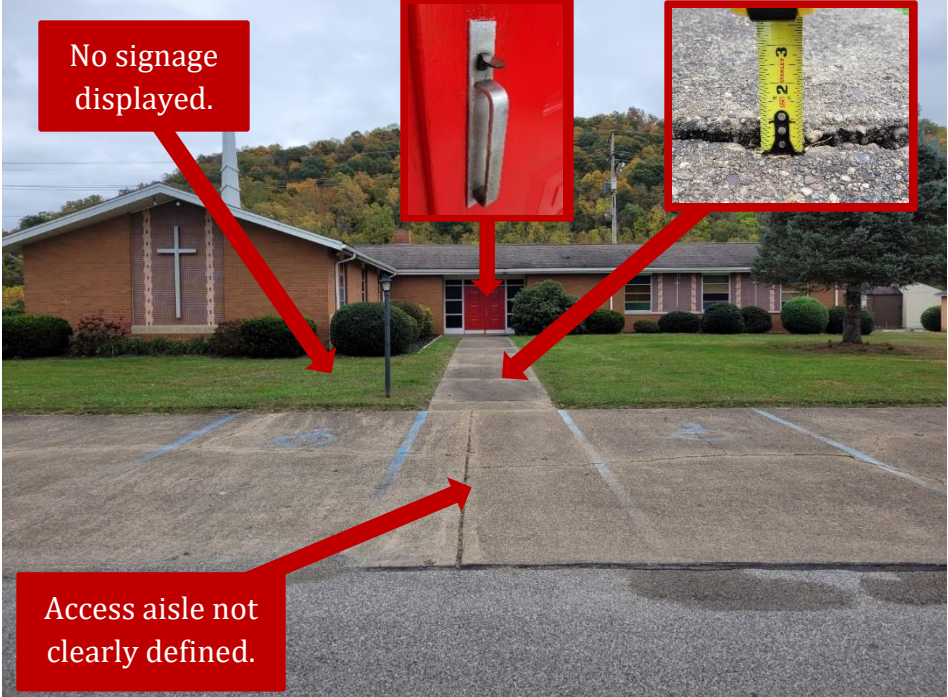
<p>The photograph shows the entrance to Mobley School House. A paved access aisle leads from a parking lot to a red door. Three callout boxes highlight issues: 'No signage displayed.' points to the lack of an accessible parking sign; 'Access aisle not clearly defined.' points to the lack of clear markings on the pavement; and a close-up of the door handle shows it is a traditional knob, not accessible hardware. An inset image shows a yellow measuring tape indicating a 3-inch gap in the pavement.</p>
<p>Suggestions for ADA Compliance</p>	<p>Install accessible parking signage at the required height, ensuring at least one space is designated to be van accessible. Mark the access aisle in a way that discourages parking within it. Utilize a mat to cover the opening in the pavement to ensure a stable, firm, and non-slip surface on the accessible route. Replace the inaccessible door hardware with a push, pull, or loop hardware or prop the door open during election hours.</p>

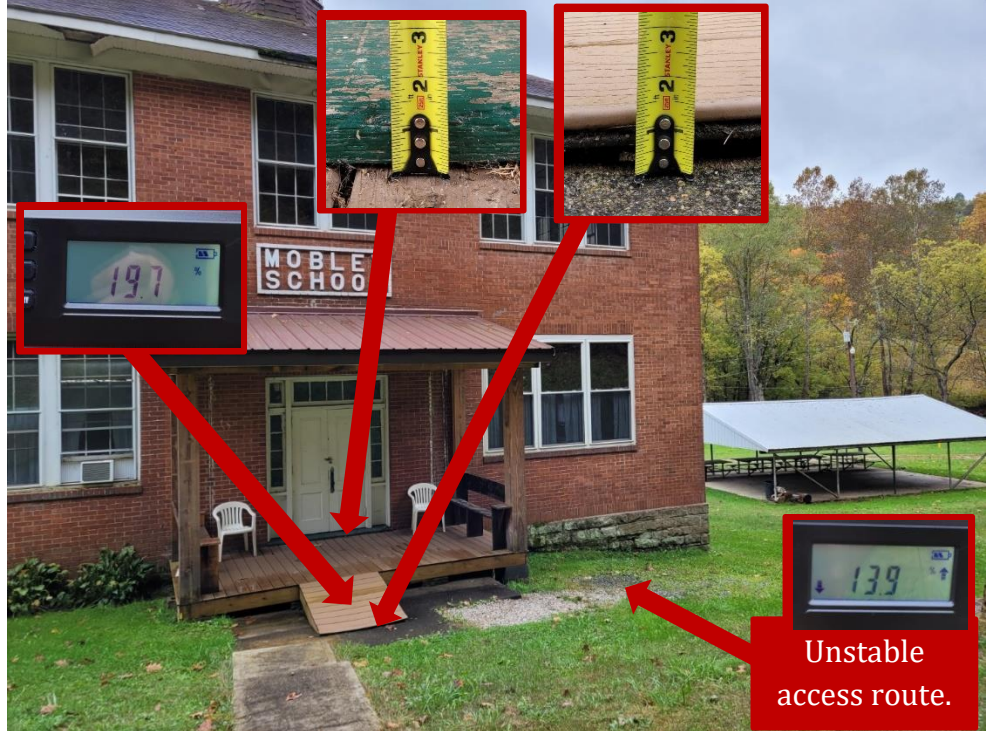
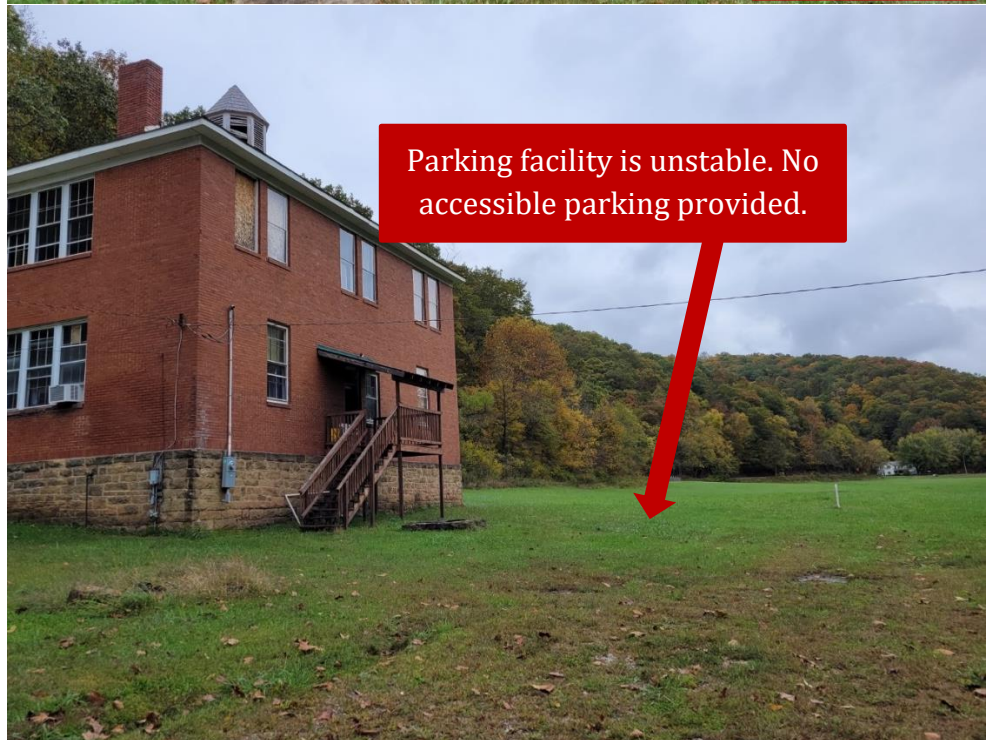
<p>Mobley School House</p>	
<p>Issue(s)</p>	<p>The parking facility is unstable due to grass (502.4). The access route is unstable due to slope, gravel, and grass (403.1). No accessible parking is provided (502.2). The slope of the ramp exceeds ADA Standards (405.2). There is a 1 ½-inch lipped edge at the bottom of the ramp (303.4). There is a 1 ¼-inch lipped edge at the entrance door (303.4).</p>

Relocation may be the best option for this polling site, unless there is another entrance that better complies with ADA Standards, or the issues identified are addressed.

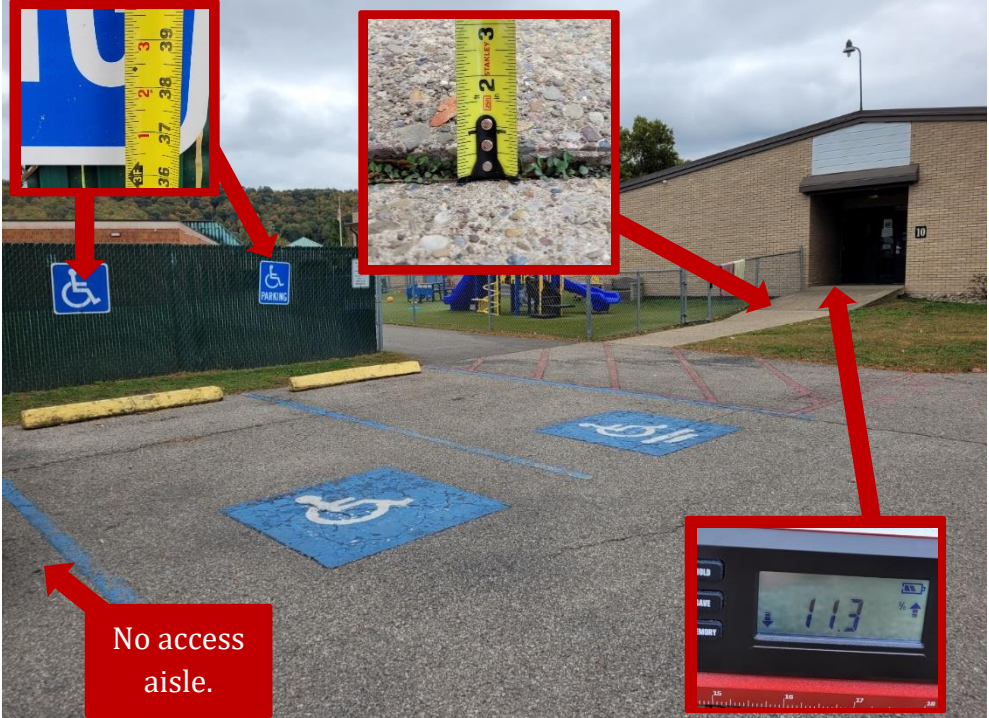
New Martinsville School

Issue(s)	The existing accessible parking signage is not displayed at the proper height (502.6). Neither accessible parking space has an adjoining access aisle nor are they van accessible (502.2, 502.3). The slope of the ramp exceeds ADA Standards (405.2). There is a ½-inch crack in the pavement causing an obstruction on the access route (302.1, 403.2).
Exhibit

<p>The exhibit photograph shows an accessible parking lot with several blue-painted spaces. Red callout boxes highlight specific issues: one shows a sign mounted too high on a fence; another shows a 1/2-inch crack in the pavement; a third shows a steep ramp leading to a building entrance; and a fourth shows a red box with the text 'No access aisle.' pointing to a narrow path between spaces.</p>
Suggestions for ADA Compliance	Since the slope of the accessible route exceeds ADA Standards for ramps, it cannot be utilized unless the structure is rebuilt entirely. It may be best to identify an alternative entrance that complies with ADA Standards. Try to select an entrance that is closest to the accessible parking facility. Designate at least one of the parking spaces to be van accessible, with appropriate signage and an access aisle. <i>Note: While the left parking space is missing an access aisle, only one accessible parking space is required. Therefore, installing an access aisle for the additional space is not required so long as the right parking space is adjusted to meet ADA Standards.</i>

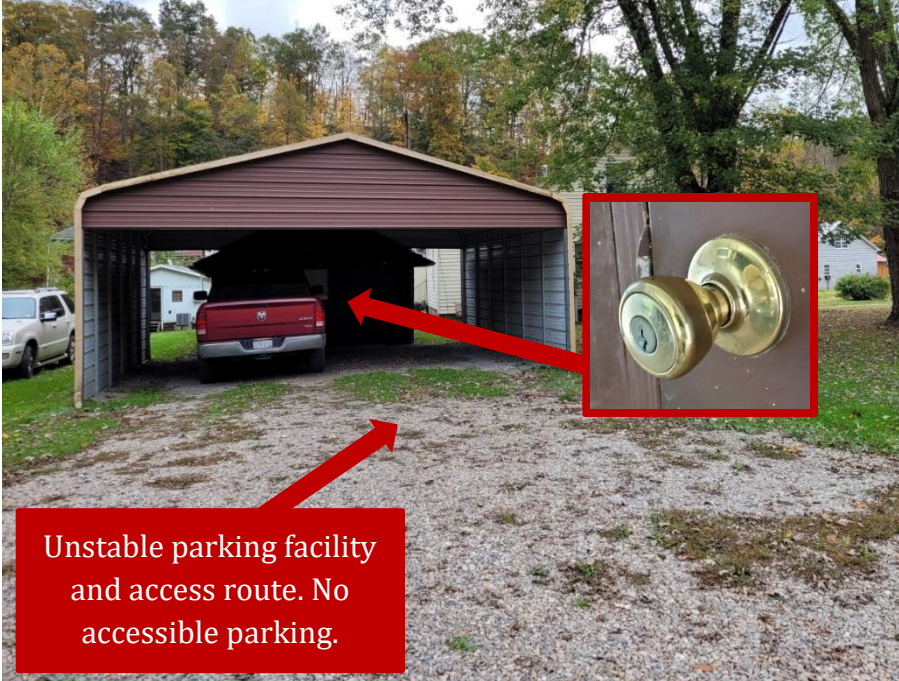
<p>Raymond Lasure's Building</p>	
<p>Issue(s)</p>	<p>The parking facility and access route are unstable due to gravel (502.4). There is no van accessible parking space provided (502.2). The door hardware is inaccessible (309.4).</p>
<p>Exhibit</p>

Suggestions for ADA Compliance	Install a paved area for an accessible parking facility or utilize temporary measures. Note that the parking facility and parked vehicles cannot obstruct the accessible route to the entrance. Replace the inaccessible door hardware with a push, pull, or loop hardware, or prop the door open during election hours.
---------------------------------------	--

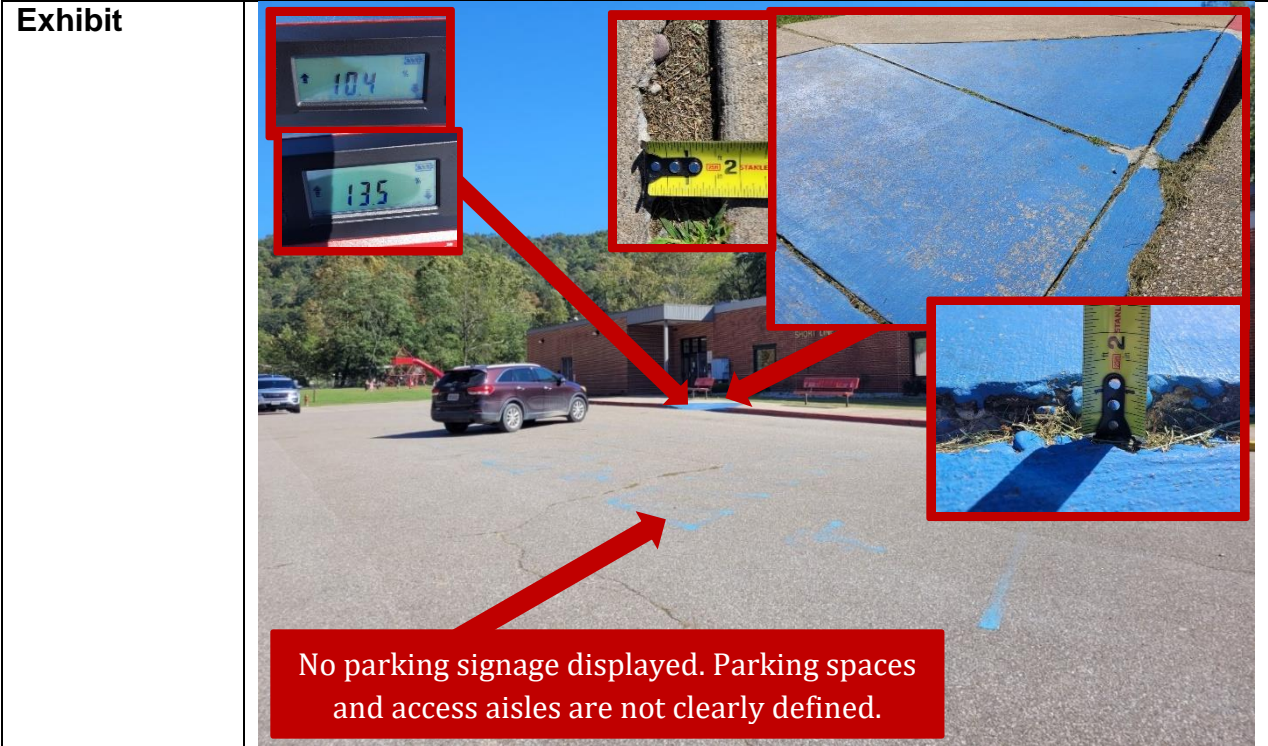
Short Line School

Issue(s)	No accessible parking signage displayed (502.6). The accessible parking spaces are not clearly defined by the painted lines (502.2). The slope of the curb ramp and flared sides exceed ADA Standards (405.2, 406.3). The pavement on the curb ramp is damaged, causing the access route to be unstable (403.2, 405.4).
-----------------	---

<p>Suggestions for ADA Compliance</p>	<p>Since the slope of the curb ramp exceeds ADA Standards for ramps, it cannot be utilized unless the structure is rebuilt entirely. Additionally, the damaged areas on the curb ramp would be difficult to solve without further increasing the slope of the curb ramp. Clearly identify the accessible parking spaces and access aisles with striped lines. Designate at least one of the parking spaces to be van accessible, with appropriate signage.</p>
--	--

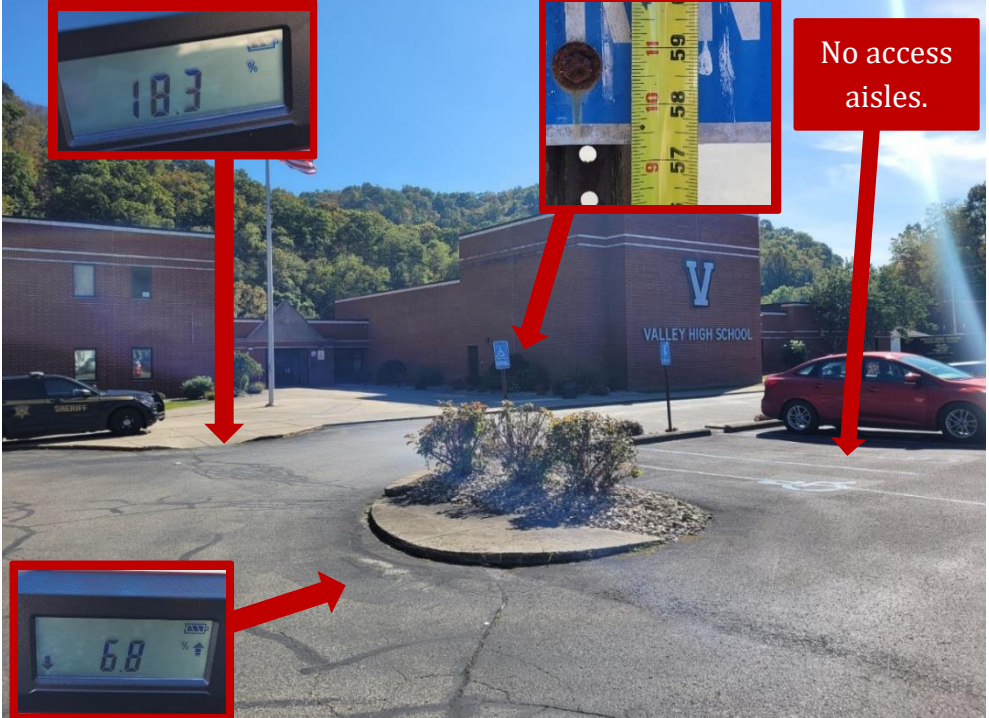
<p>Valley High School</p>	
<p>Issue(s)</p>	<p>The accessible parking signage is not displayed at the proper height (502.6). The slope of the access route exceeds ADA Standards (402.2). There are no access aisles provided (502.3). The flared edges of the curb ramp exceed ADA Standards (406.3).</p>

<p>The photograph shows a parking lot at Valley High School. Three callouts are present: 1) A red box around a digital sign displaying '183' with a red arrow pointing to a signpost. 2) A red box around a coin-operated sign with a red arrow pointing to a signpost. 3) A red box with the text 'No access aisles.' and a red arrow pointing to a parking space. A fourth red box around a digital sign displaying '68' has a red arrow pointing to a parking space.</p>
<p>Suggestions for ADA Compliance</p>	<p>Adjust the existing accessible parking signage to the proper height. Designate at least one accessible parking space to be van accessible. Adjust the curb ramp to comply with ADA Standards. It may be best to identify another entrance at this location to utilize for election day that better complies with ADA Standards.</p>

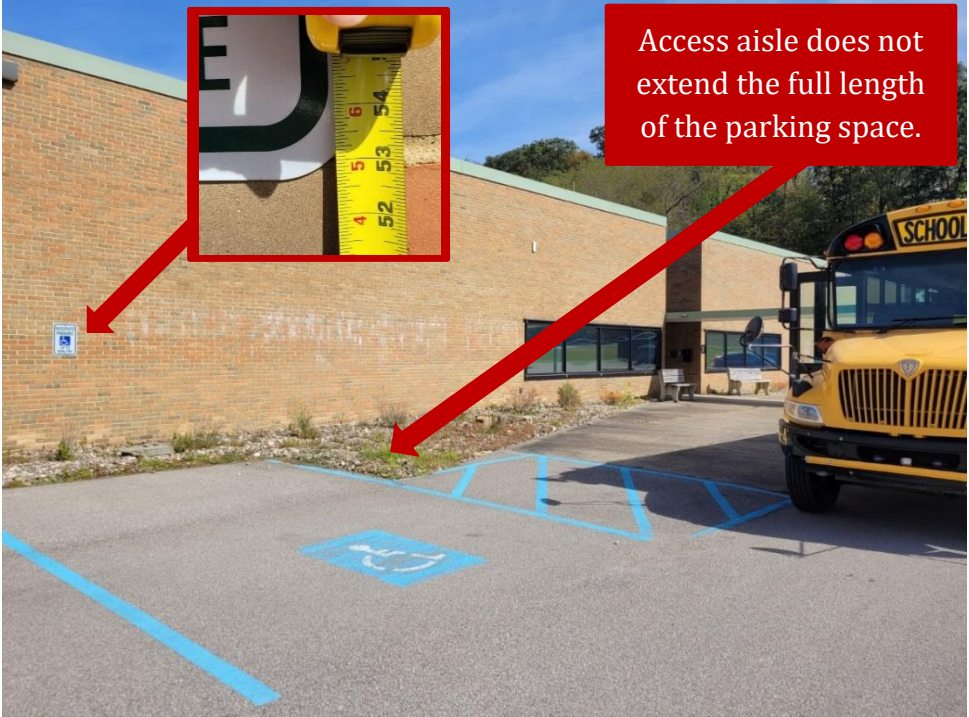
<p>Wetzel County Technical Center</p>	
<p>Issue(s)</p>	<p>The existing accessible parking signage is not displayed at the proper height (502.6). The accessible parking space is not designated as van accessible (502.2). The parking space's adjoining access aisle does not extend the full length of the accessible parking space (502.2, 502.3).</p>

<p>Suggestions for ADA Compliance</p>	<p>Adjust the existing accessible parking signage to the proper height. Designate at least one accessible parking space to be van accessible. Adjust the access aisle (relocating to the other side of the parking space may be best), ensuring it extends the full length of the parking space.</p>
