2023 Polling Site Accessibility Report: Hardy County, WV

On October 25 and 26, 2023, a DRWV Advocate completed exterior accessibility monitoring of all precincts in Hardy County and this report contains our findings. The following ADA codes referenced below are the most common issues noted in this county.

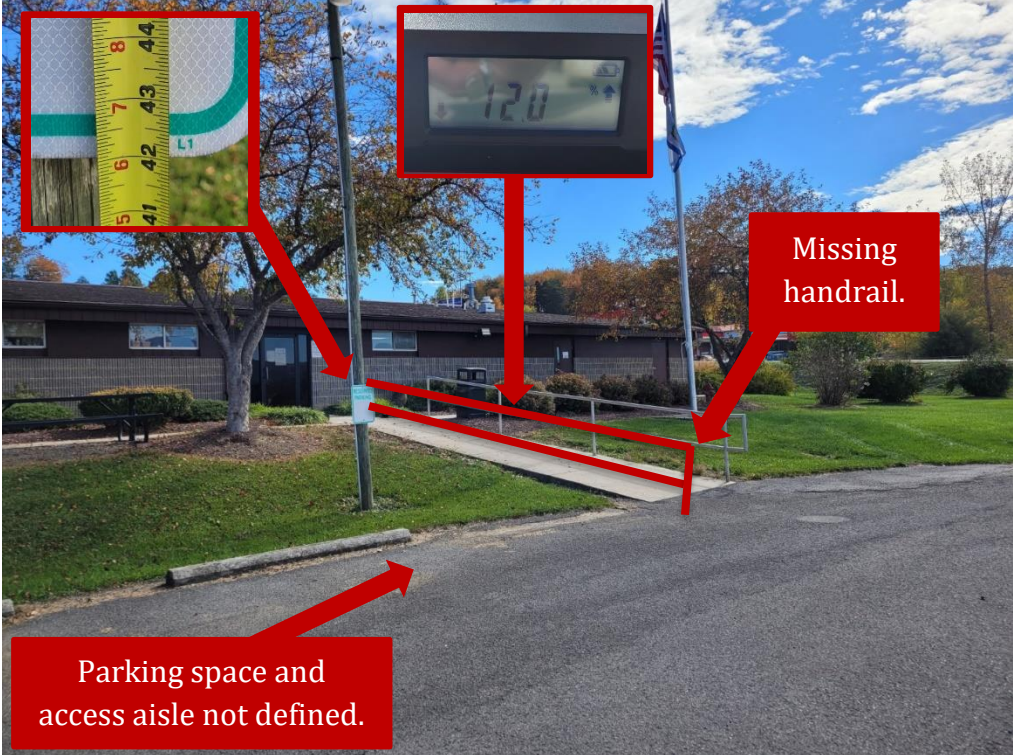
Agriculture Building	
Issue(s)	The slope of the ramp exceeds ADA Standards (405.2). There are missing handrails on the left side of the ramp (405.8). The accessible parking space and access aisle are not clearly defined (502.2). The accessible parking signage is not displayed at the proper height (502.6).
Exhibit

<p>The photograph shows an exterior ramp leading to a building. Three red callout boxes with arrows point to specific areas: one points to a yellow measuring tape held against a white handrail, another points to a digital sign displaying '120' mounted on a pole, and a third points to the left side of the ramp where a handrail is missing. A fourth red callout box with an arrow points to the asphalt area in front of the ramp, indicating that the parking space and access aisle are not clearly defined by painted lines.</p>
Suggestions for ADA Compliance	<p>Install painted lines to clearly define the accessible parking space and access aisle, ensuring it meets ADA size requirements for a van accessible space. Replace the existing signage with van accessible signage, ensuring it is displayed at the proper height. Adjust the ramp so the slope does not exceed 8.33% and install a handrail on the left side.</p> <p>Alternatively, if there is another entrance at this location that complies with ADA guidelines, it can be used for election day.</p>

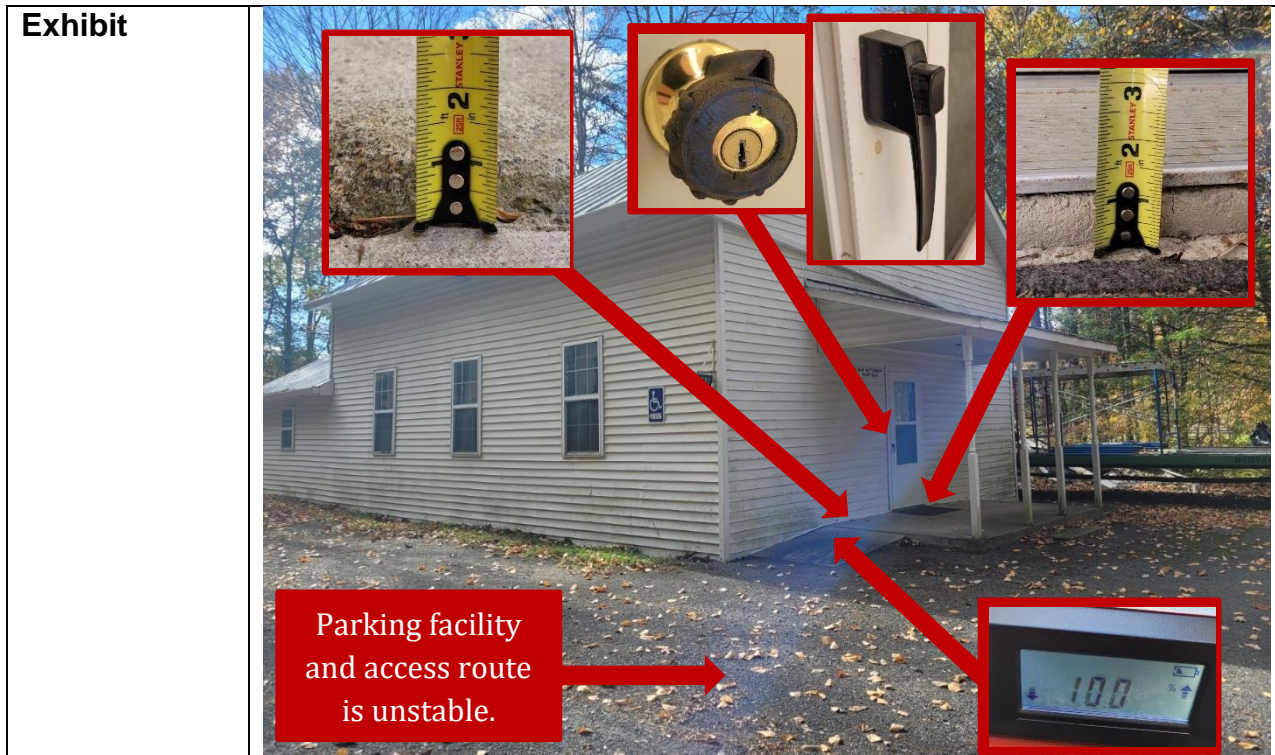
<p>Bean Settlement Community Building</p>	
<p>Issue(s)</p>	<p>Unstable parking facility and access route (302.1, 402.2, 502.4). There is no van accessible parking space provided (502.2). The door hardware is inaccessible (309.4). There is a 1-inch lipped edge at the door's threshold (303.4). There is a 1-inch lipped edge at the top of the ramp (303.4, 405.4). The slope of the ramp exceeds ADA Standards (405.2).</p>

Reconstruct the existing ramp, ensuring there is no lipped edge and the slope of does not exceed 8.33%. Alternatively, a temporary ramp system that complies with ADA Standards could be installed. Install a paved area for at least one van accessible parking space and access aisle, ensuring it meets the minimum size requirements outlined in the ADA Standards. Replace the existing signage with van accessible signage displayed at the minimum required height. Utilize a wedge to resolve the lipped edge at the door threshold. Replace the inaccessible door hardware with a push, pull, or loop hardware, or prop the doors open during election day in a manner that does not obstruct the accessible route.

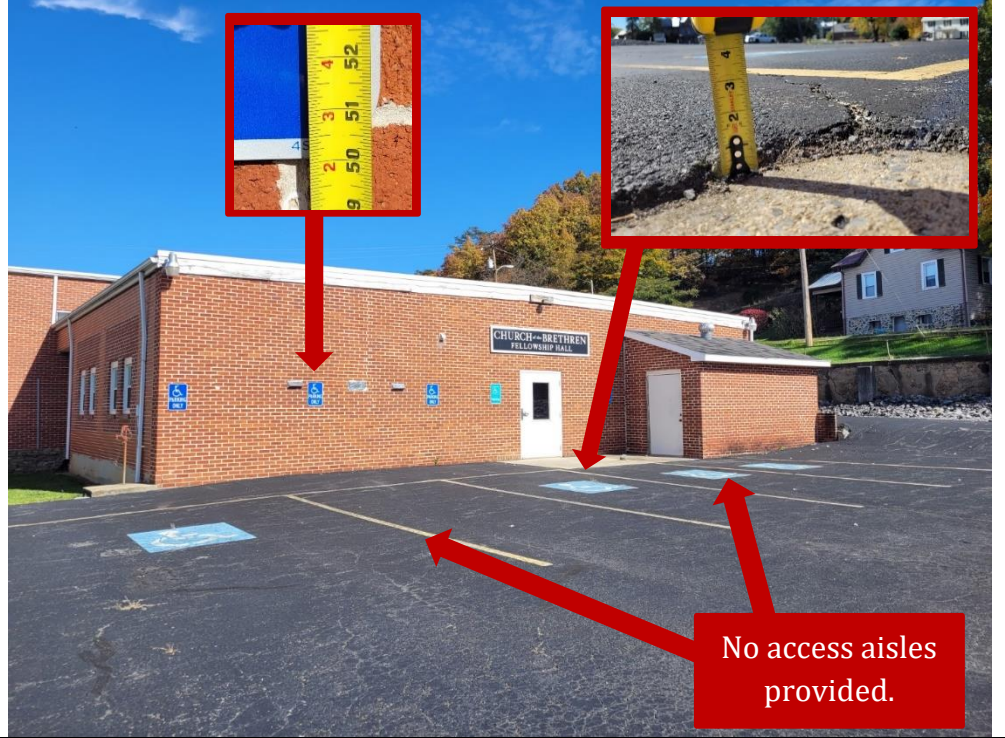
<p>Exhibit</p>

Church of the Brethren Fellowship Hall	
Issue(s)	The existing parking signage is not displayed at the proper height (502.6). There is no space designated as van accessible (502.2). The accessible parking spaces do not have adjoining access aisles (502.2, 502.3). The pavement on the accessible route is damaged, causing a 1/2-inch lipped edge (302.1, 402.2).

<p>Suggestions for ADA Compliance</p>	<p>Utilize a temporary mat or bevel the lipped edge on the pavement to resolve the obstruction on the accessible route. Adjust the existing parking signage to be displayed at the proper height. Designate at least one of the accessible parking spaces to be van accessible, ensuring the appropriate signage is displayed and that it meets ADA size requirements. Install access aisles, marked in a manner that discourages parking within them.</p>

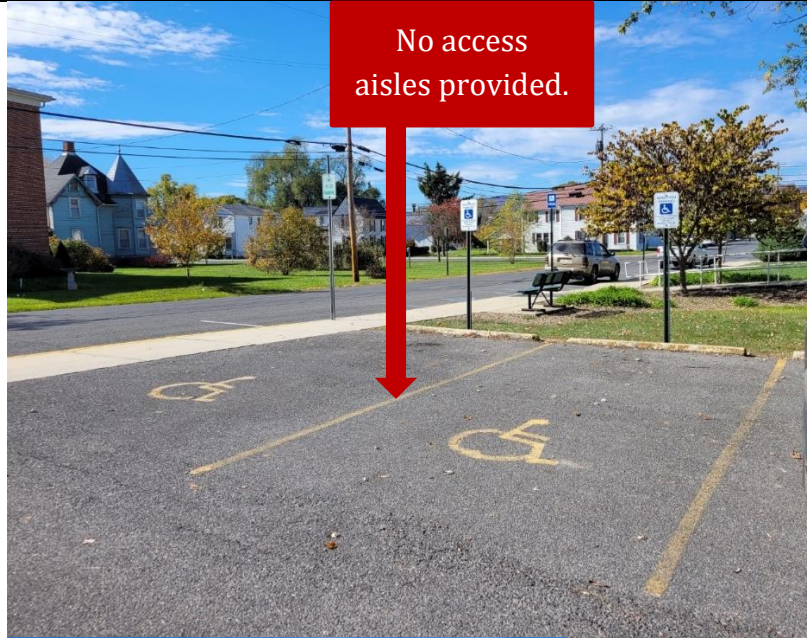
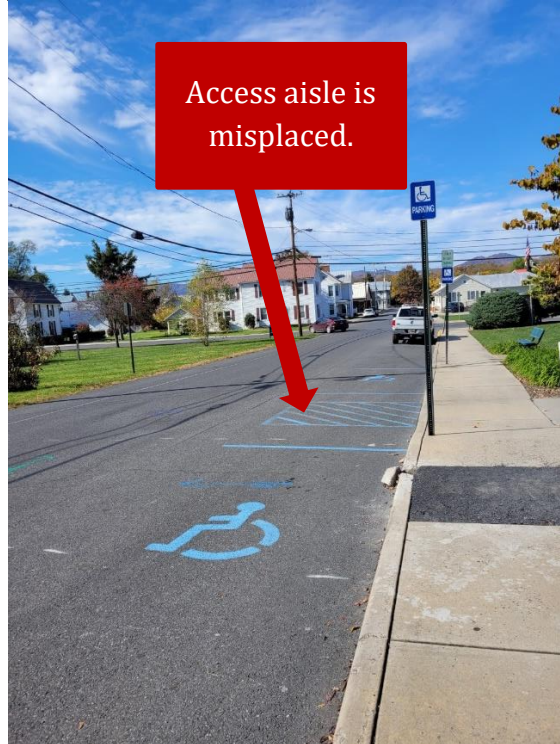
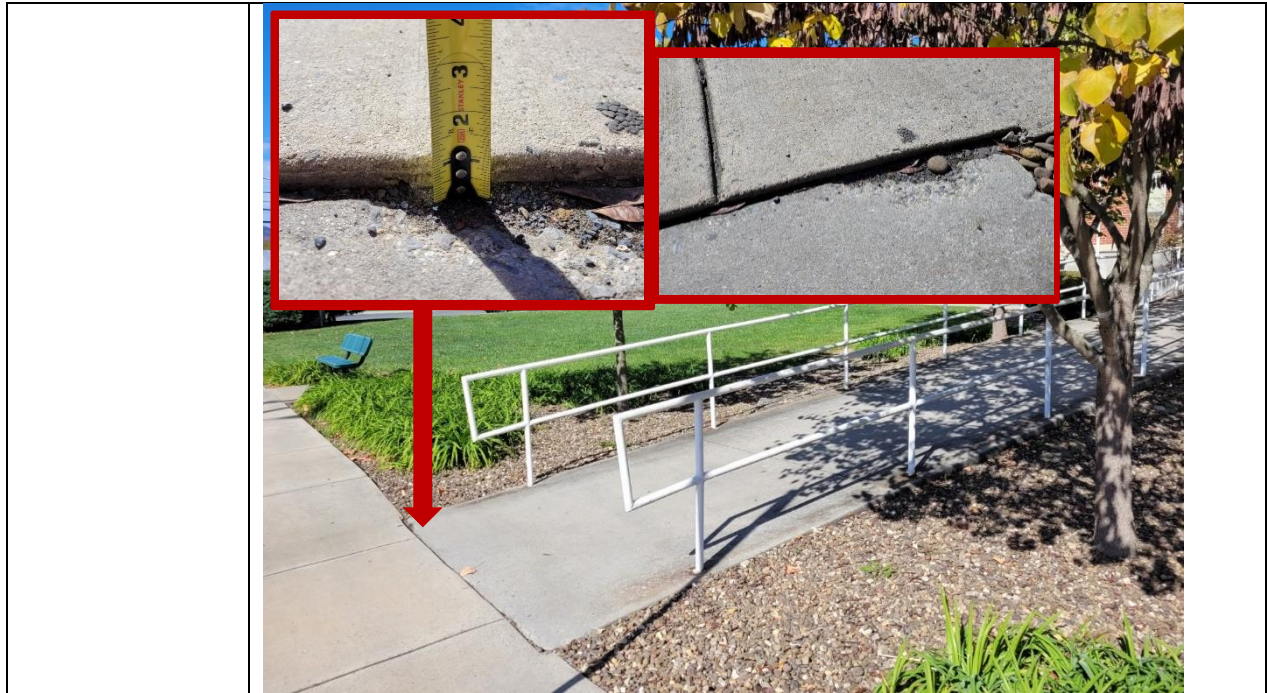
Exhibit

<p>Hardy County Courthouse</p>	
<p>Issue(s)</p>	<p>The accessible parking spaces in the parking facility do not have adjoining access aisles (502.2, 502.3). The access aisle near the parallel accessible parking spaces is not placed correctly (502.3). There is no accessible parking space designated as van accessible (502.2, 208.2.4). There is a 1-inch lipped edge caused by a damaged area in the pavement, at the bottom of the ramp (303.4, 405.4).</p>

<p>Suggestions for ADA Compliance</p>	<p>Utilize a temporary mat or repair the damaged area of the pavement to resolve the 1-inch lipped edge. Install at least one van accessible parking space, with an adjoining access aisle and appropriate signage. <i>Note: There only needs to be one van accessible parking space meeting ADA requirements. Whichever solution is most feasible would suffice.</i></p>
--	---

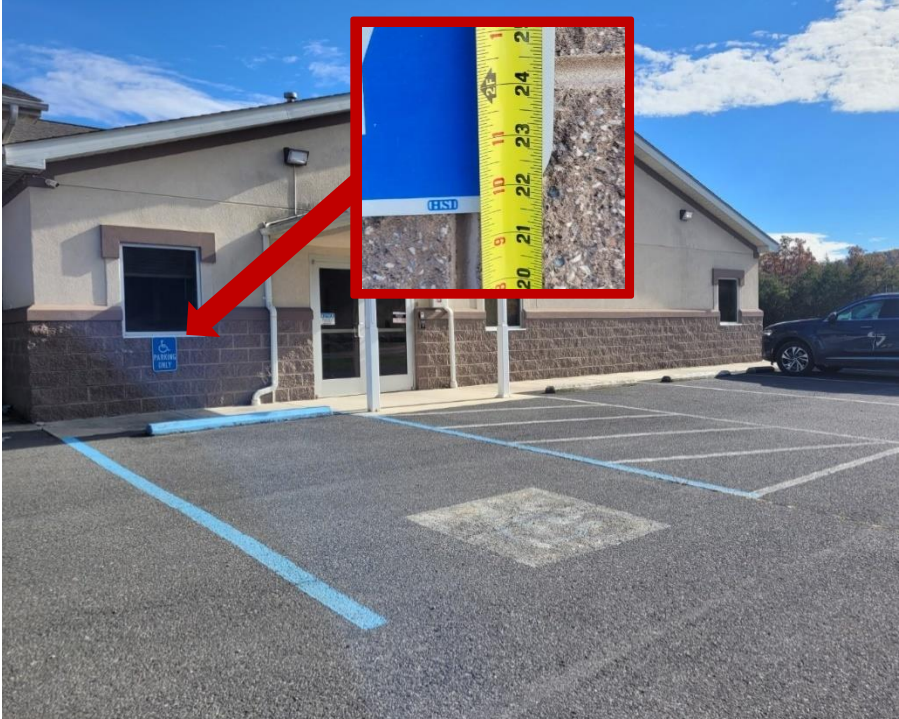
<p>Exhibit</p>

<p>Hardy County Emergency Ambulance Authority</p>	
<p>Issue(s)</p>	<p>The existing accessible parking signage is not displayed at the proper height, nor is it van accessible (208.2.4, 502.6).</p>

<p>Suggestions for ADA Compliance</p>	<p>Adjust the existing parking signage to the minimum height required by the ADA Standards and install a “van accessible” sign with it.</p>

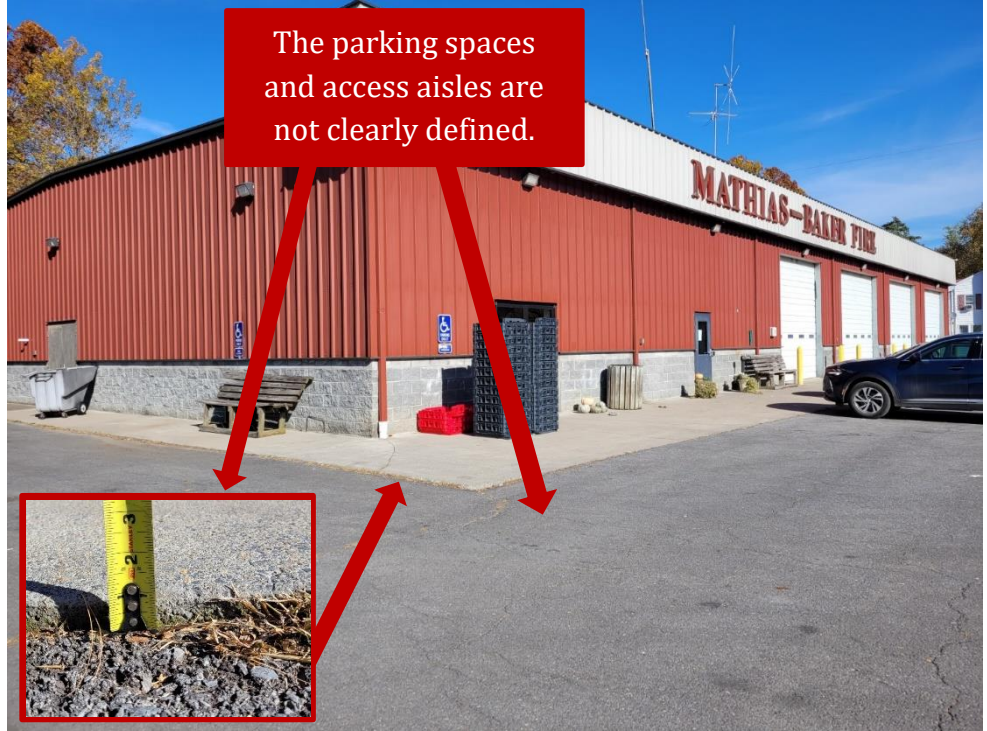
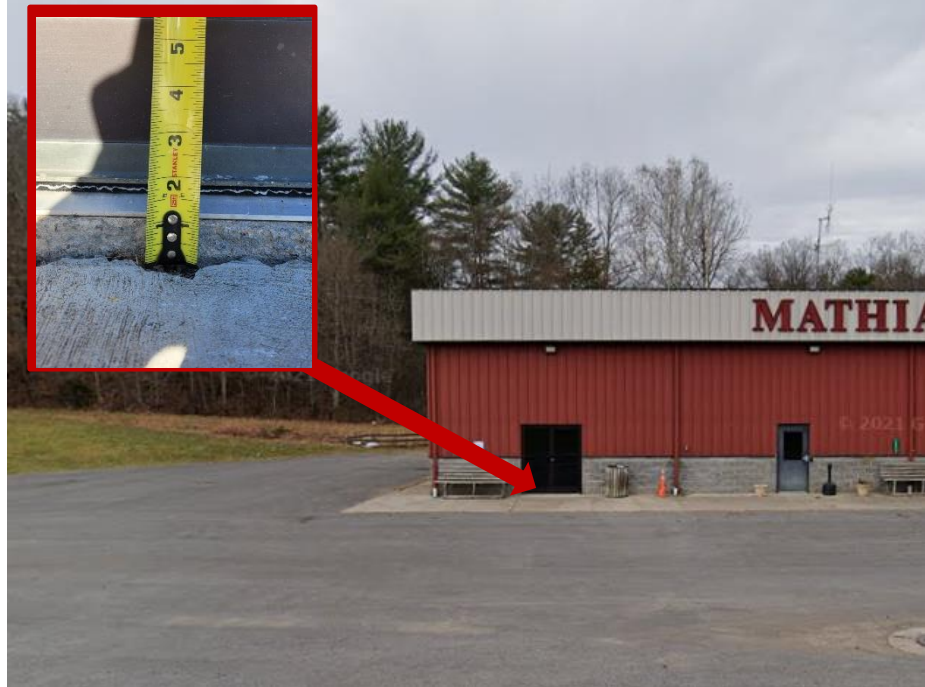
Exhibit

<p>Mathias-Baker Fire Dept.</p>	
<p>Issue(s)</p>	<p>The accessible parking spaces and access aisles are not clearly defined (502.3, 502.6). There is a ¾-inch lipped edge on the access route along with overgrown weeds causing an obstruction for the path of travel (302.1, 303.4). There is a 1-inch lipped edge at the entrance door (303.4)</p>

Clearly define the accessible parking spaces and access aisles using striped lines or temporary measures, ensuring at least one meets requirements to be a van accessible space. Resolve the lipped edges on the pavement by ramping them or utilizing temporary measures, such as a mat or wedge.

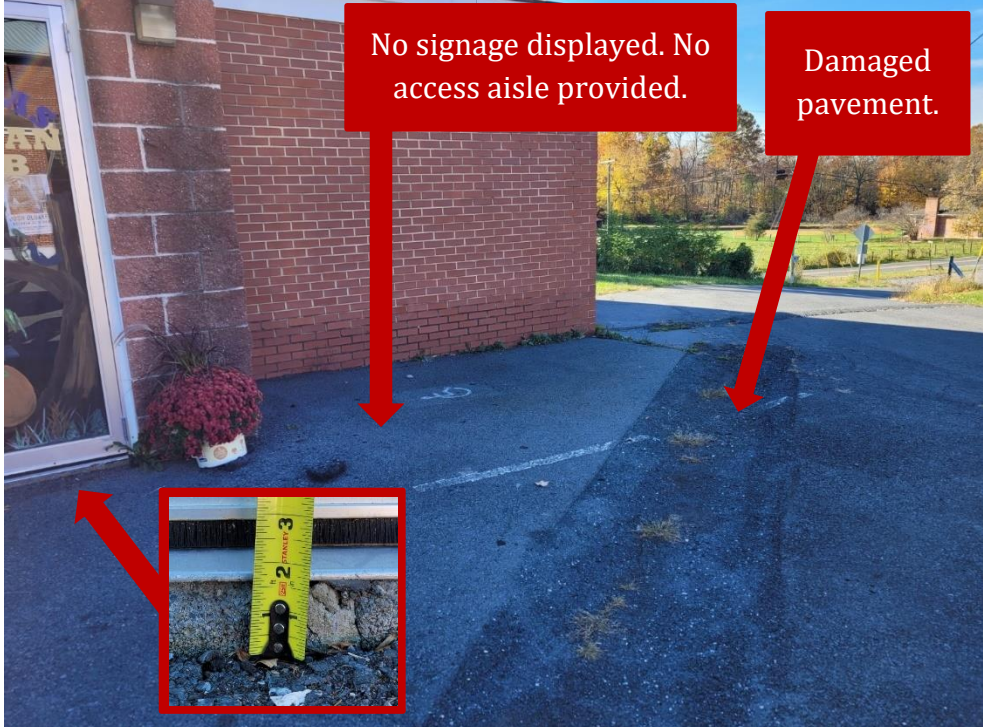
Issue(s)	No accessible parking signage is displayed (502.6). The accessible parking space does not have an access aisle, nor is it designated to be van accessible (502.2, 502.3). There are damaged areas in the pavement where the accessible parking space is located (302.1, 502.4). There is a 1 and ½-inch lipped edge at the entrance door (303.4).
Exhibit

Suggestions for ADA Compliance	Ramp the 1 and ½-inch lipped edge at the door or utilize a temporary wedge to resolve it. Relocate the accessible parking space, ensuring it is located on a level, paved area. Ensure the accessible space has an access aisle, to the size requirements outlined in the ADA Standards and marked in a manner that would discourage parking within it. Install van accessible parking signage.

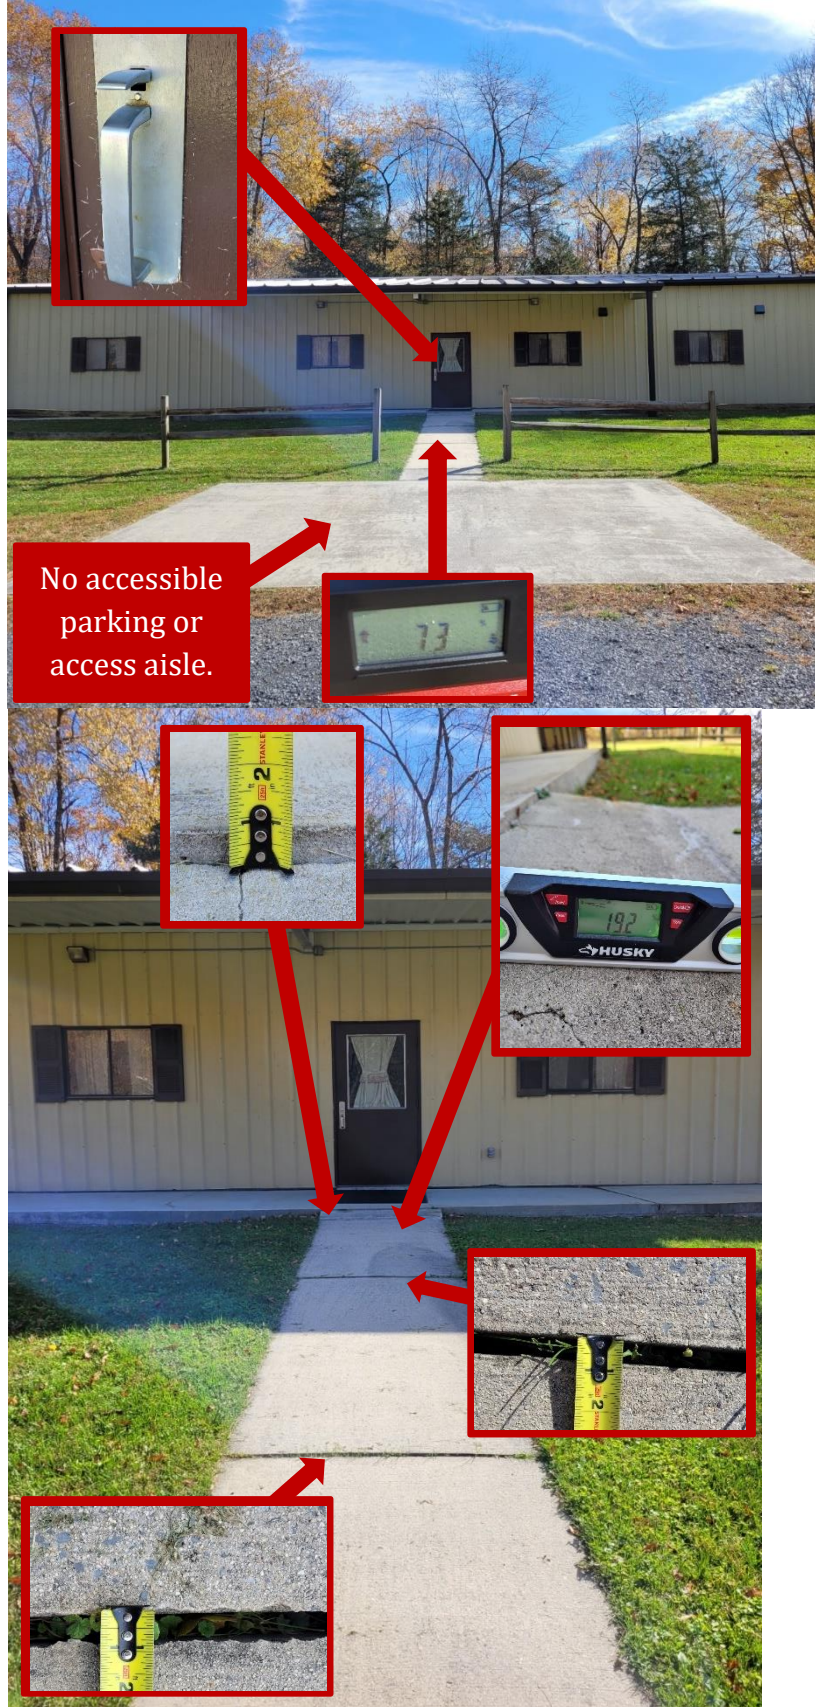
Exhibit

<p>Peru Community Center</p>	
<p>Issue(s)</p>	<p>1st Photo – There is not a van accessible parking space or access aisle provided (502.2, 502.3). The slope of the accessible route (7.3%) exceeds ADA Standards (402.2). The door hardware is inaccessible (309.4) 2nd Photo – There are 1-inch openings on the access route (302.1, 402.2). There is a ¾-inch lipped edge at the top of the access route (303.4). The slope of the ramped section at the top of the accessible route (19.2%) exceeds ADA Standards (405.2, 405.7).</p>

Suggestions for ADA Compliance	Install one van accessible parking space and access aisle within the paved area, ensuring it meets size requirements outlined in the ADA Standards. Install van accessible parking signage to the minimum required height. Utilize mats or repair the gaps in the pavement, to resolve the 1-inch openings on the access route. The slope of the sidewalk exceeds ADA Standards for an accessible route (max 5%); However, the slope is within the required range for a ramp (max 8.33%). Therefore, if proper handrails are installed, it would be in compliance with ADA Standards. Additionally, the slope of the top ramp portion (seen in photo 2) exceeds ADA Standards and there is a ¾-inch lipped edge; This section must either be reconstructed or resolved using temporary measures.
---------------------------------------	--

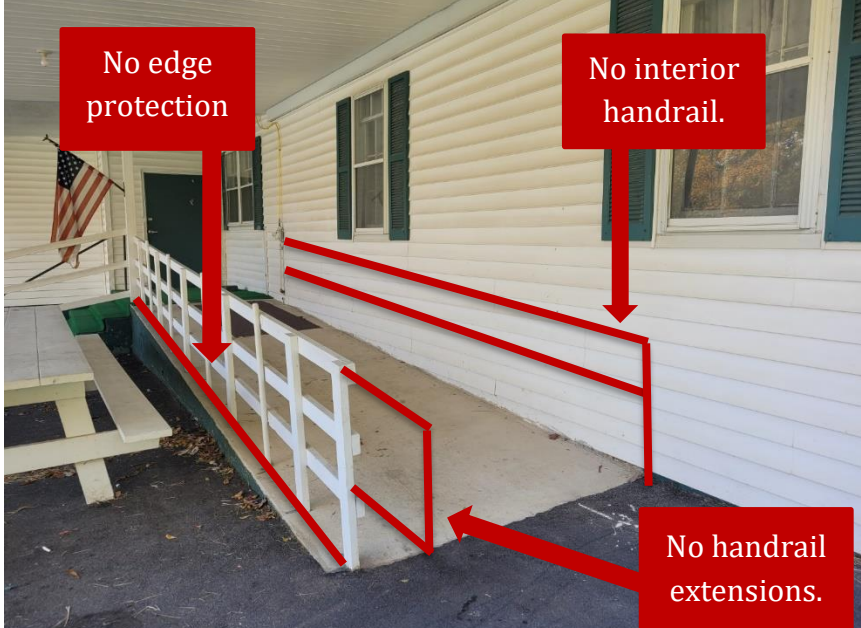
Rig Civic Center	
Issue(s)	1st Photo – Ramp does not have an interior handrail, handrail extensions, or edge protection (405.8, 405.9, 505.10.1). 2nd Photo – Ramp does not have an interior handrail or handrail extensions, and the slope of the ramp exceeds ADA Standards (405.2, 405.8, 505.10.1). There is a ¾-inch lipped edge at the door (303.4). 3rd Photo – No van accessible parking provided (502.2).
Exhibit

<p>No handrail extensions.</p> <p>No interior handrail.</p> <p>150</p> <p>No accessible parking spaces.</p>
<p>Suggestions for ADA Compliance</p>	<p>Address the issues identified with whichever ramp will be utilized during election day. Install at least one van accessible parking space and access aisle, with appropriate signage.</p>

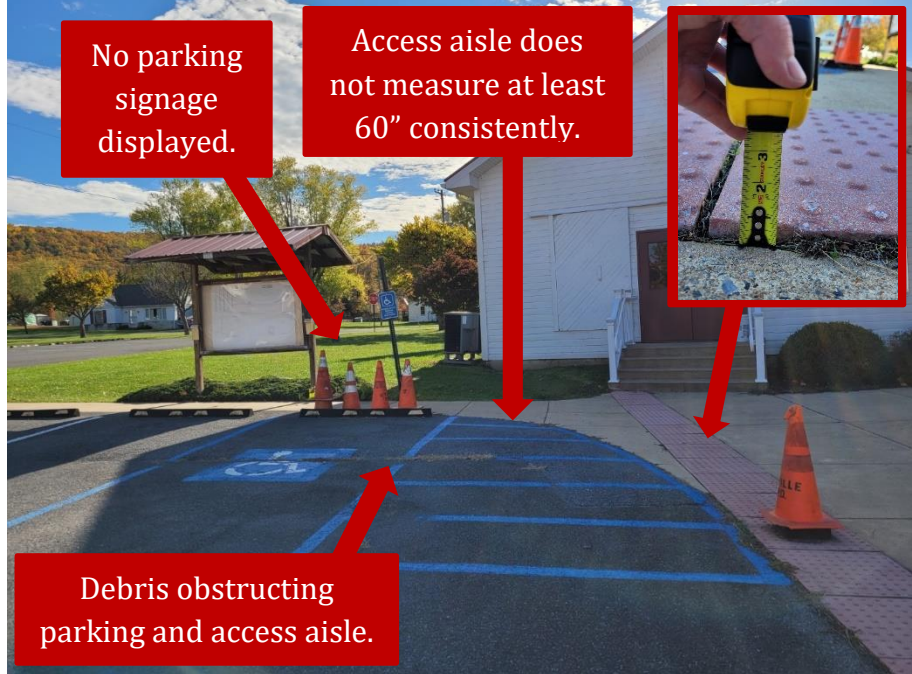
Exhibit

Wardensville Visitors Center	
Issue(s)	There is no accessible parking signage displayed, nor is the space designated to be van accessible (208.2.4, 502.2). While the access aisle does extend the full length of the parking spaces, it does not consistently measure at least 60" wide (502.3). There are damaged areas and overgrowth in the pavement, causing obstructions on the accessible route and within the accessible parking space (302.1, 502.4). The slope of the ramp exceeds ADA Standards and there is no level landing provided where the ramp changes direction (405.2, 405.7).

Access aisle does not measure at least 60" consistently.

Reconfigure the access aisle, ensuring it meets the minimum size requirements as outlined in the ADA Standards. Install van accessible parking signage. Repair the damaged areas in the pavement, clearing all debris and resolving the lipped edges. Alternatively, temporary measures such as mats could be used if they do not conform to the unstable surface. Reconstruct the ramp and address the issues identified or utilize a temporary ramp that complies with ADA Standards on election day at the side entrance.
